Annual Inspection

Fremington Parish Council

Fremington Quay

Inspection Ref: 1172196

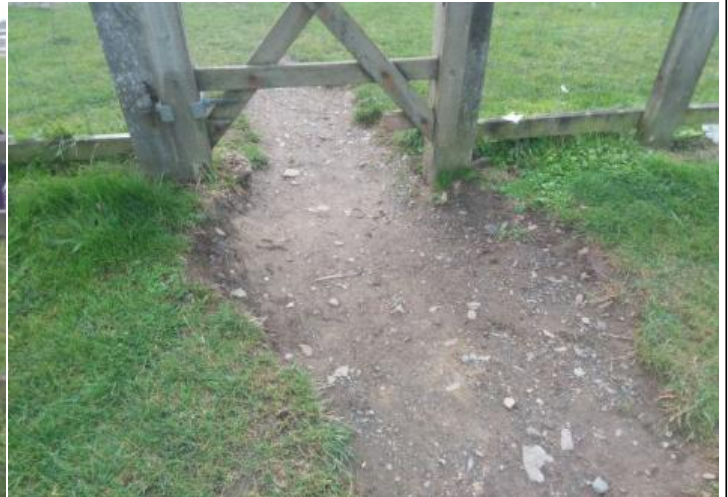
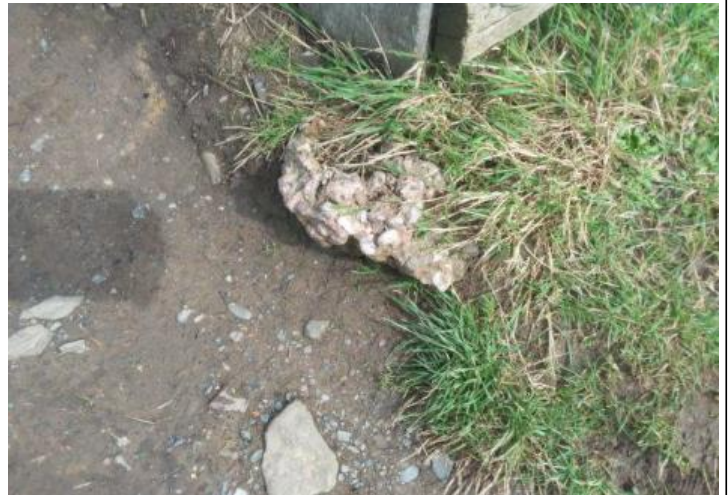
Item: Ancillary Items - Gate - Pedestrian
Manufacturer: Not Identified

Finding: The area under the gate has eroded leaving uneven areas, or the concrete foundations exposed, resulting in trip hazards at the entrance/exit to the playground

Action: Reinststate to level with surrounding surfaces

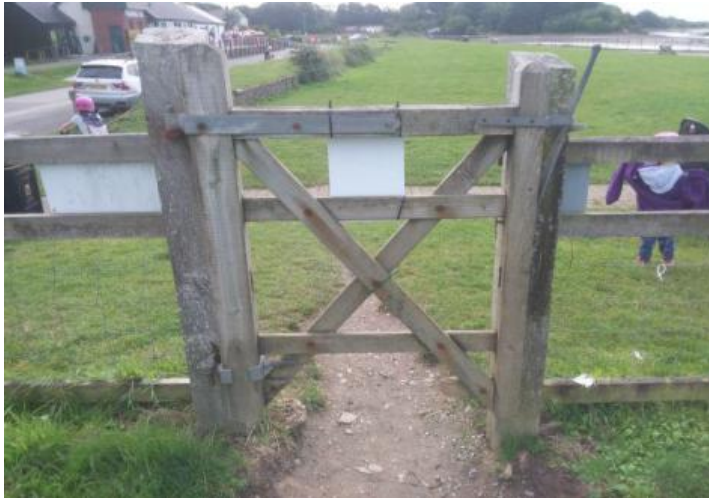
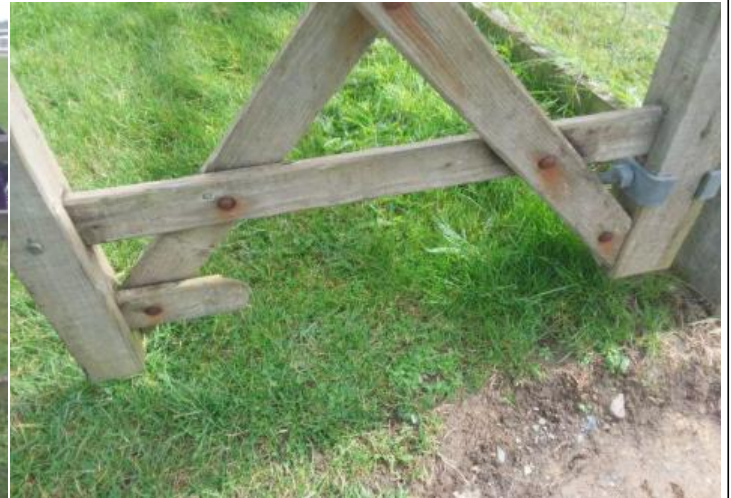
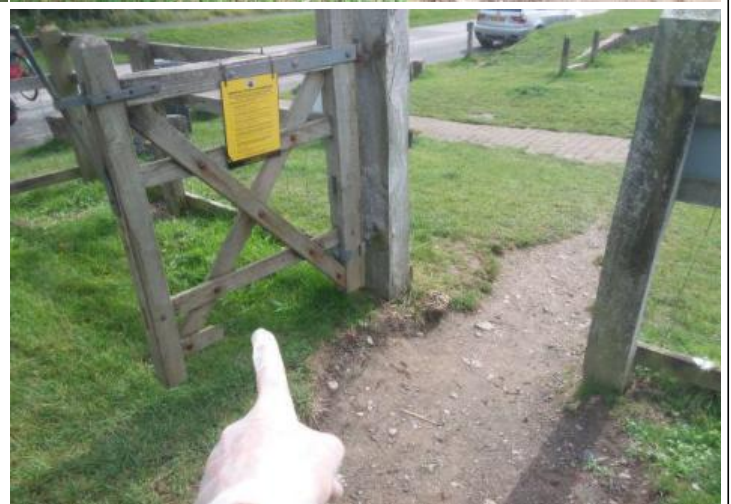
Item: Ancillary Items - Gate - Pedestrian
Manufacturer: Not Identified

Finding: The gate is damaged

Action: Repair as required

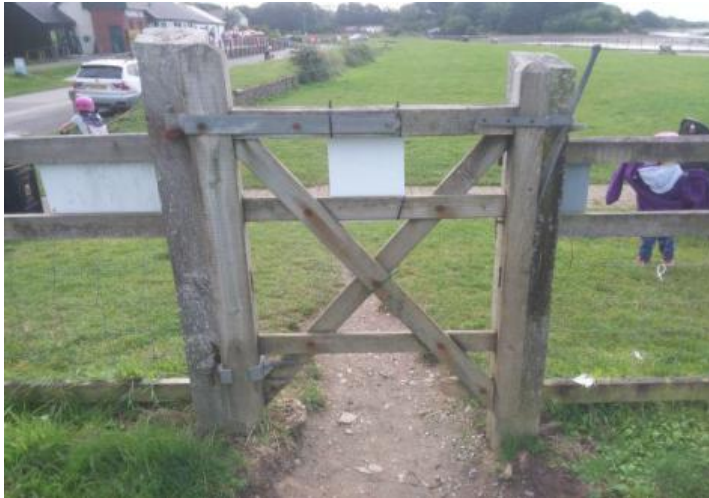
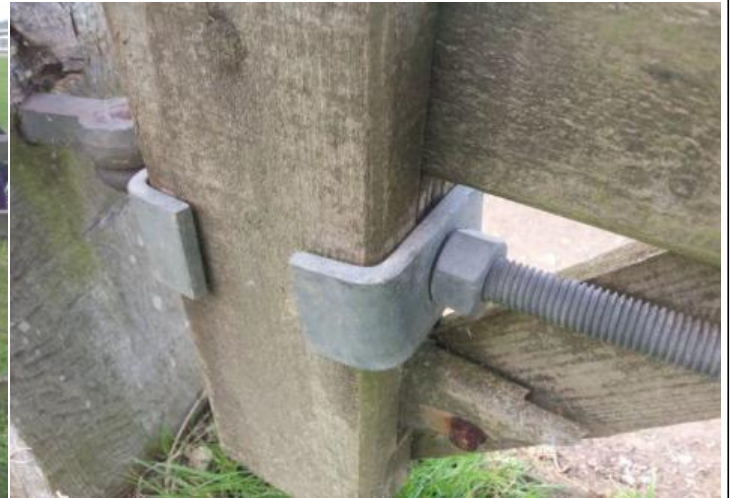
Item: Ancillary Items - Gate - Pedestrian
Manufacturer: Not Identified

Finding: A number of fixing(s) have worked loose

Action: Secure all loose fixings

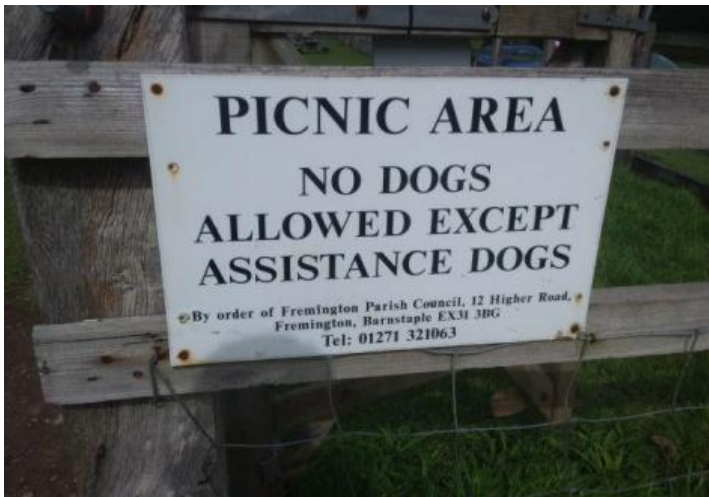
Item: Ancillary Items - Sign
Manufacturer: Owner/Operator

Finding: It is recommended that signage, with information including the site address, contact information for maintenance issues and emergency contact details are provided for the facility

Action: Provide in accordance with the recommendations

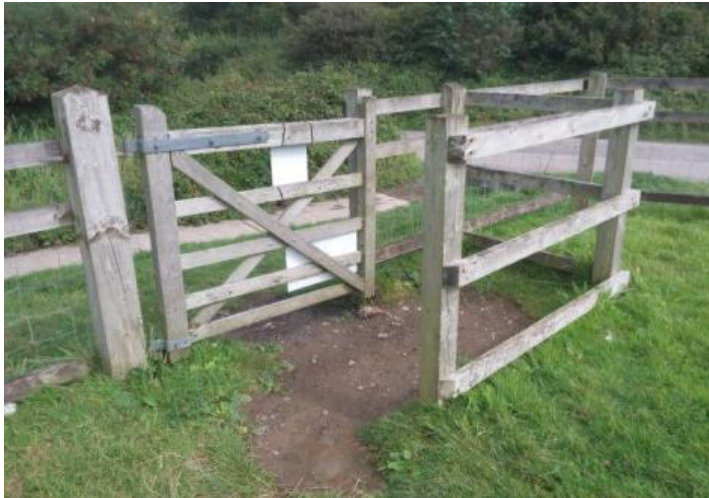
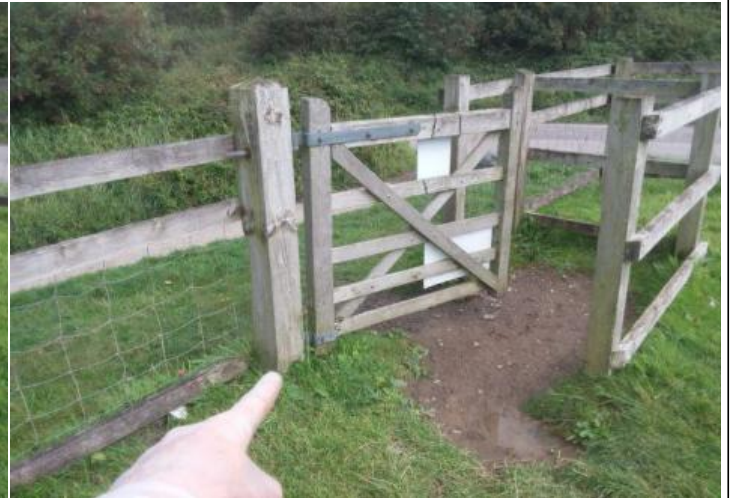
Item: Ancillary Items - Kissing Gate
Manufacturer: Not Identified

Finding: The item is loose in its foundations

Action: Reinstall item to secure

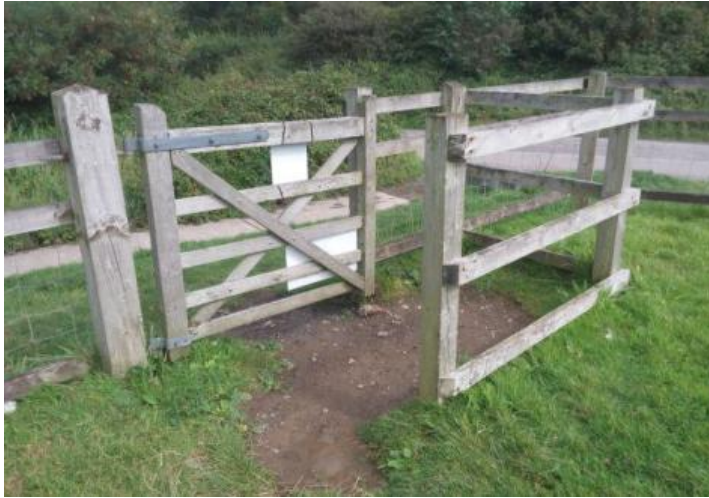
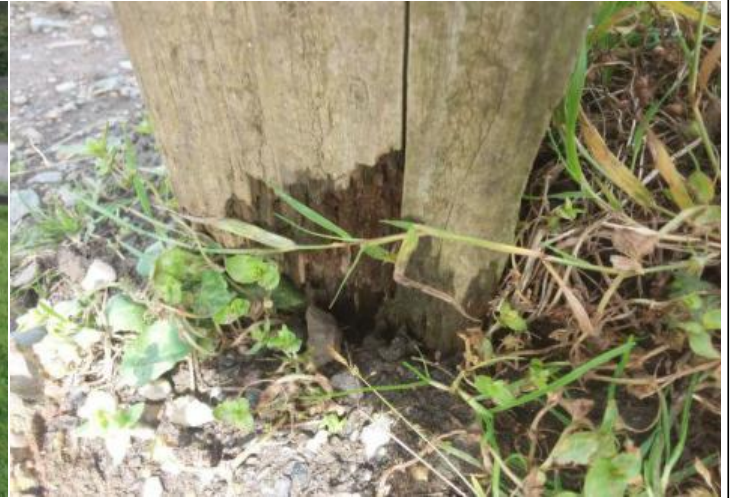
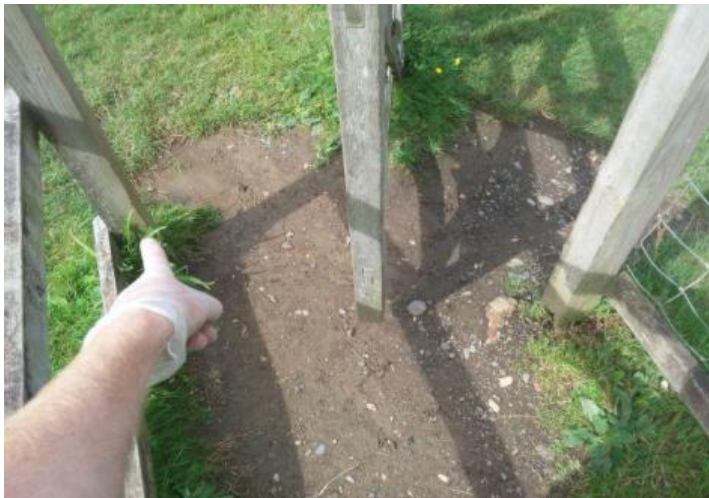
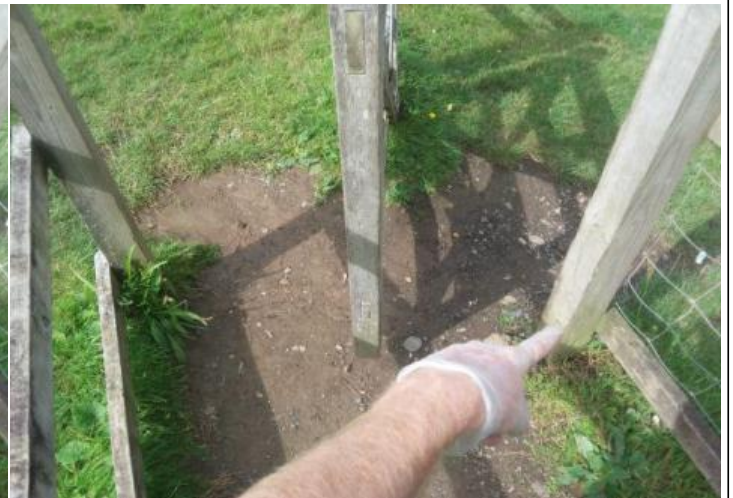
Item: Ancillary Items - Kissing Gate
Manufacturer: Not Identified

Finding: Two posts have rotted and sheared

Action: Replace

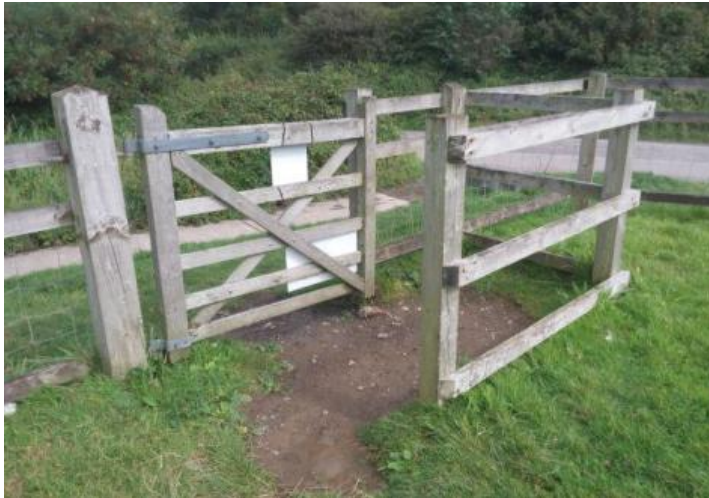
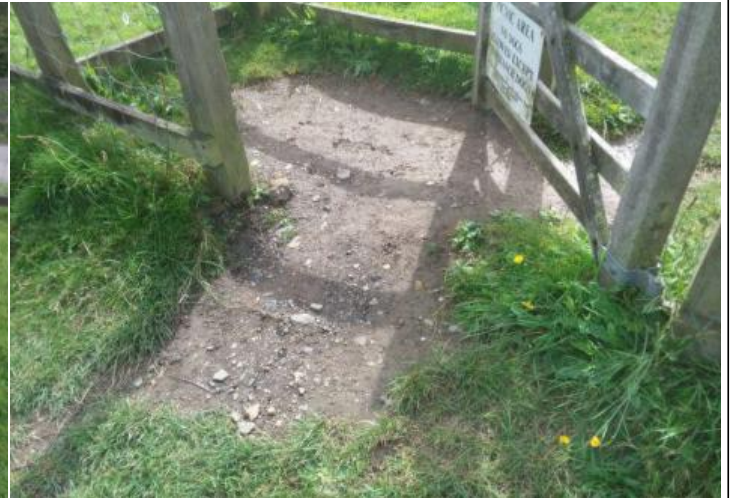
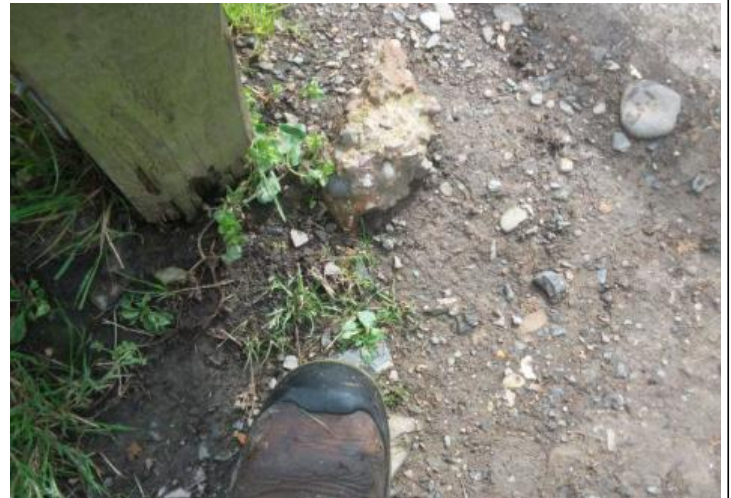
Item: Ancillary Items - Kissing Gate
Manufacturer: Not Identified

Finding: The area under the gate has eroded leaving uneven areas, or the concrete foundations exposed, resulting in trip hazards at the entrance/exit to the playground

Action: Reinststate to level with surrounding surfaces

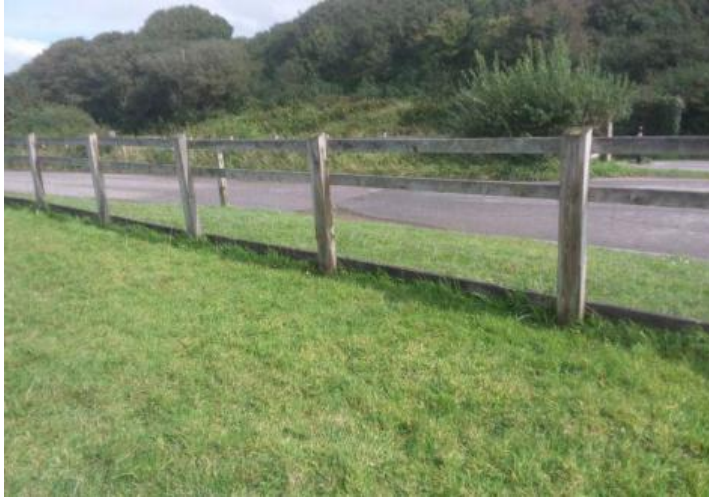
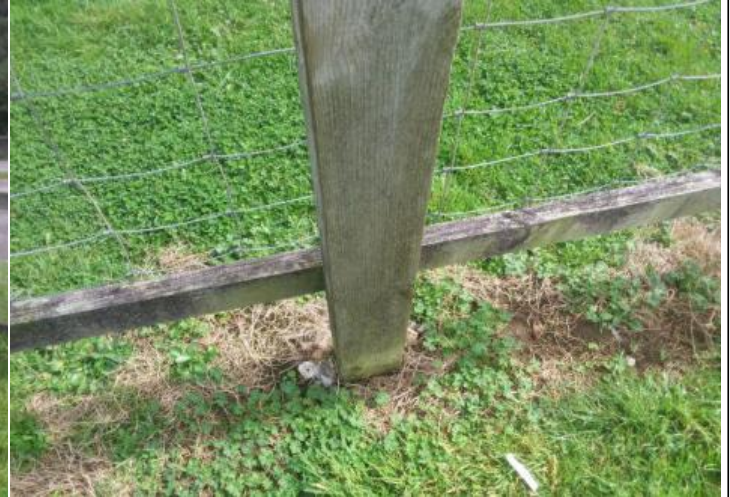
Finding: There are a number of loose posts around the fence

Action: Monitor for any further deterioration and reset as required

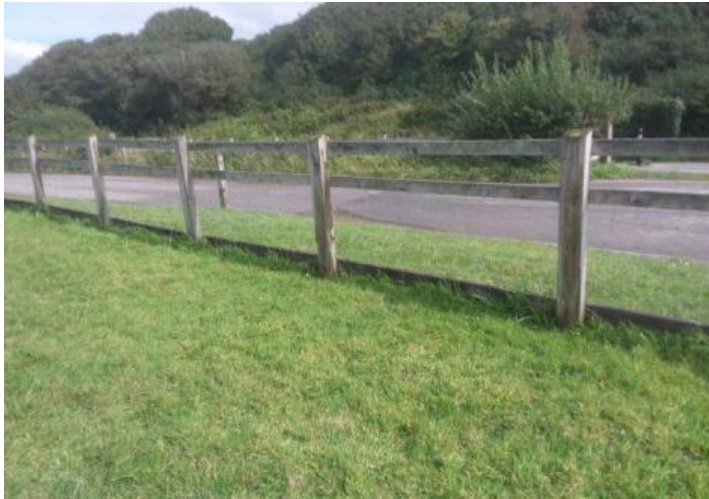
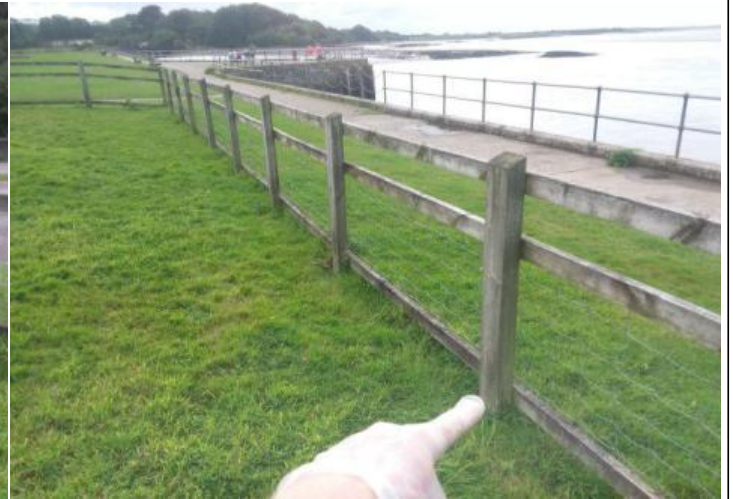
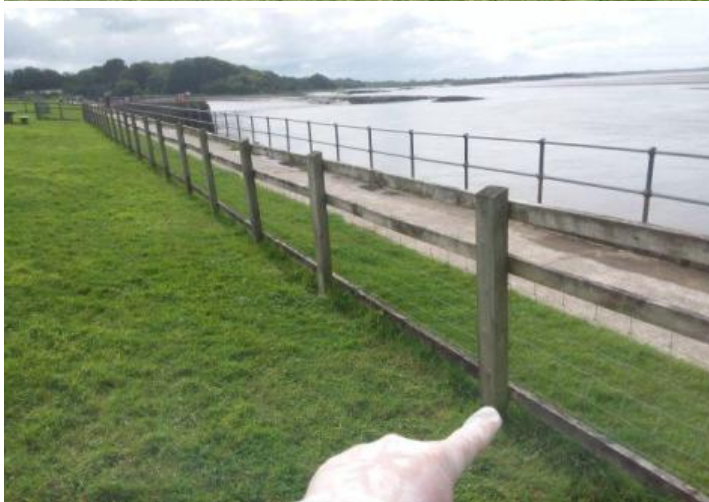
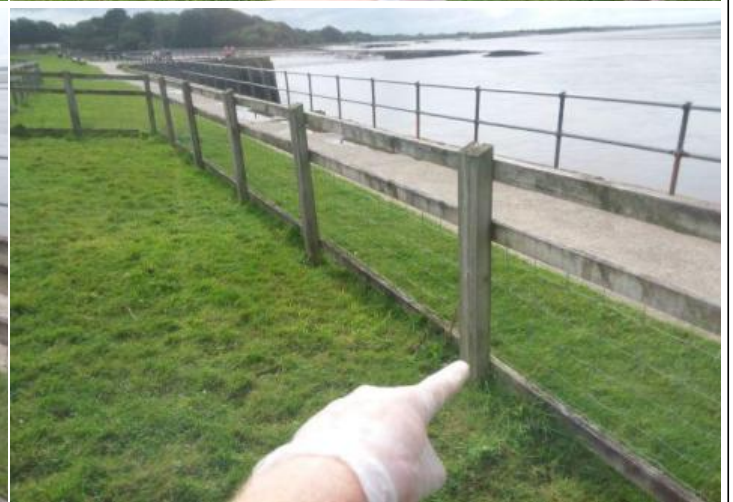
Finding: A number of posts have rotted and sheared

Action: Replace

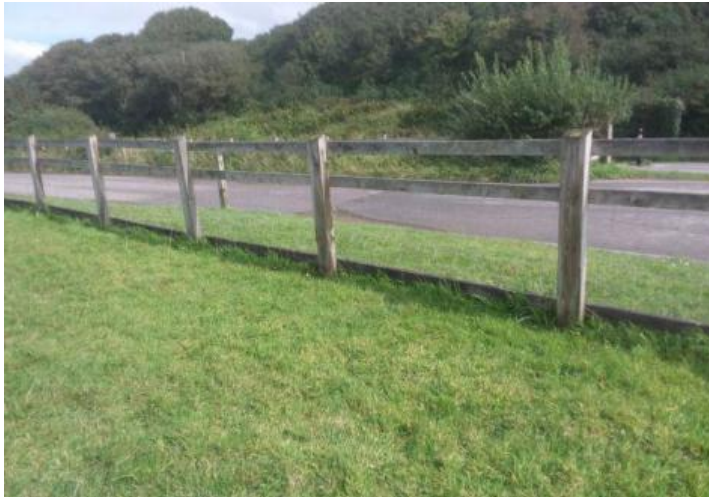
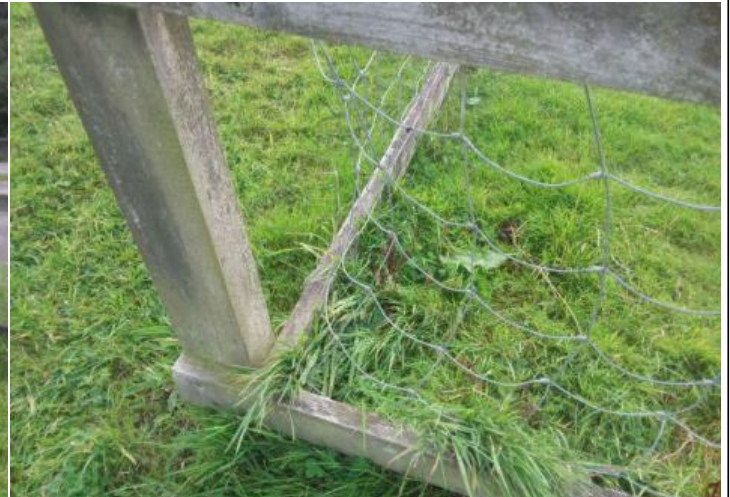
Finding: There is some damage to the fence sections

Action: Monitor for any further deterioration and repair as required

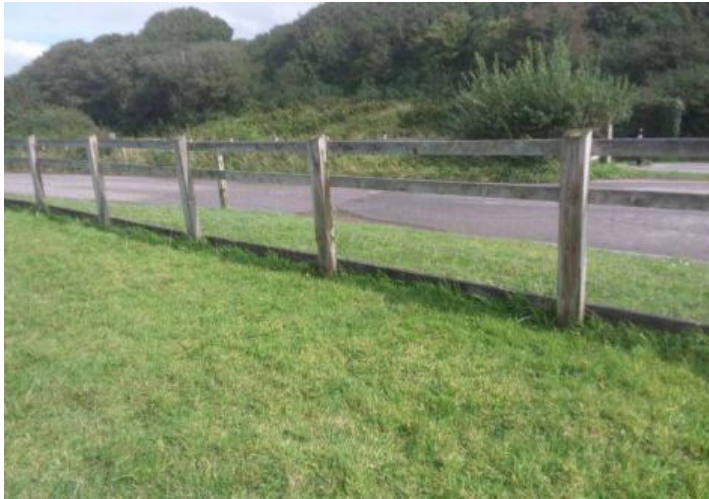
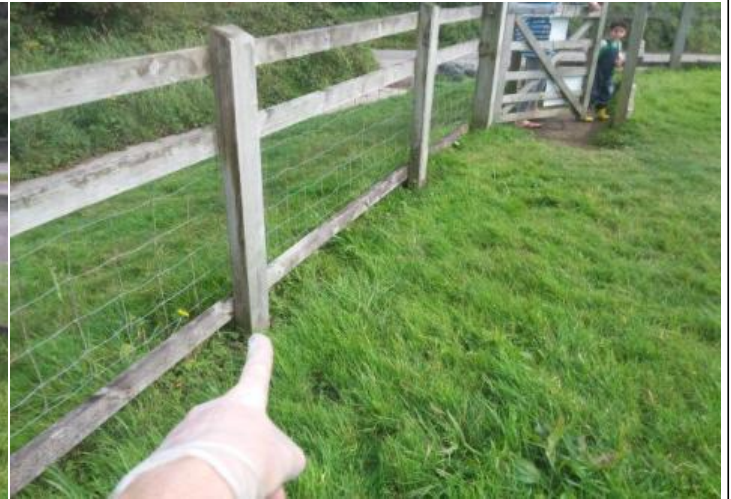
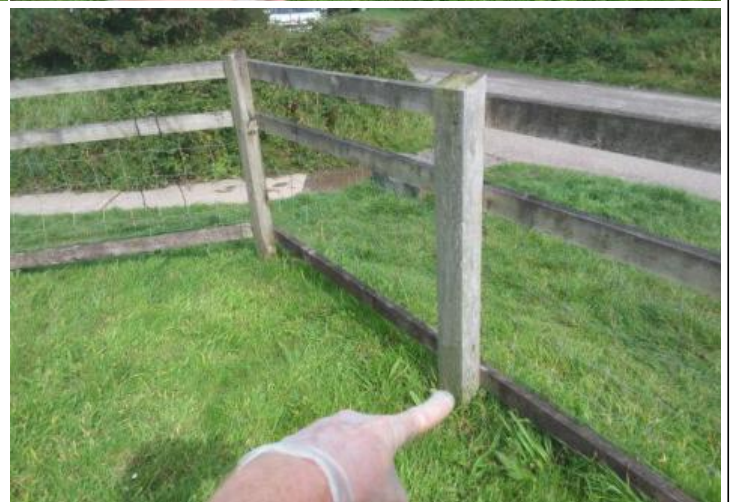
Finding: A number of posts have rotted and sheared

Action: Replace

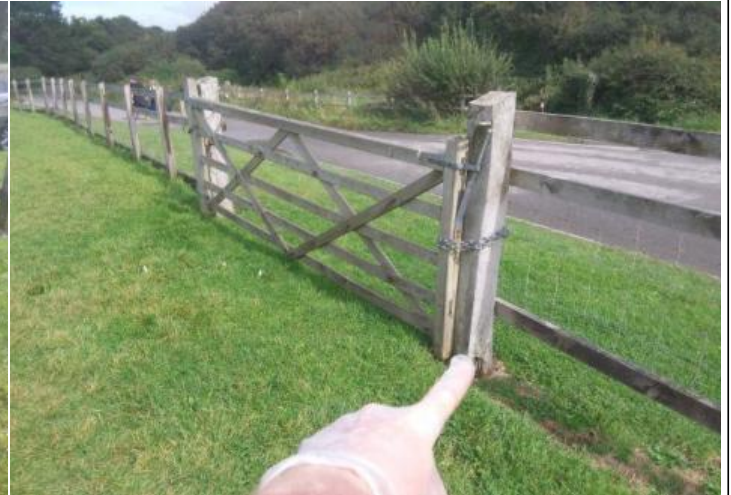
Item: Ancillary Items - Gate - Maintenance
Manufacturer: Not Identified

Finding: The post has rotted and sheared

Action: Replace

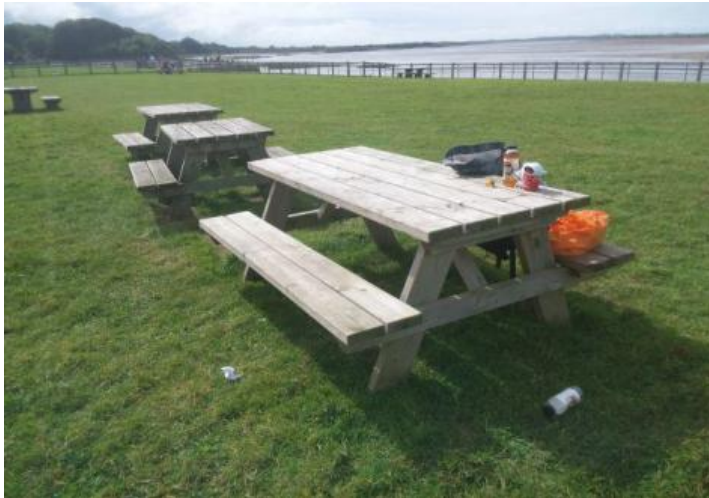
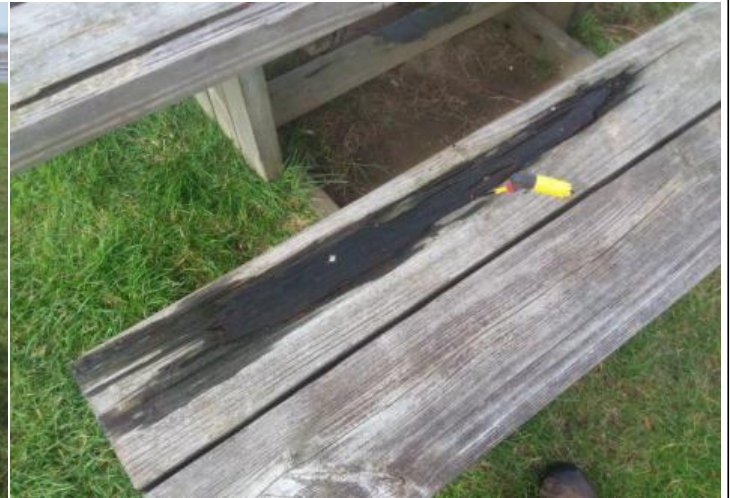
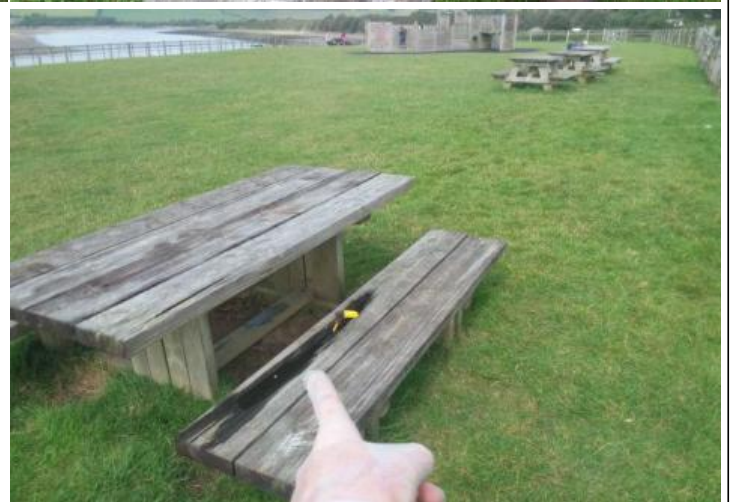
Item: Ancillary Items - Picnic Table
Manufacturer: Not Identified

Finding: There are areas or parts of the timber on the structure that have rotted

Action: Replace all affected timbers

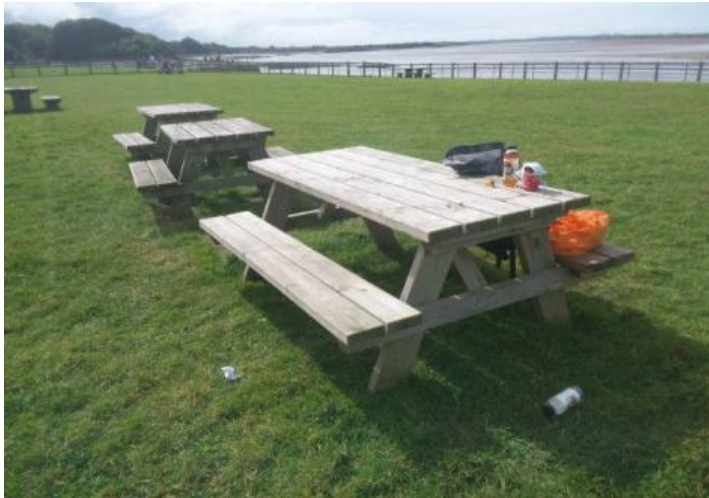
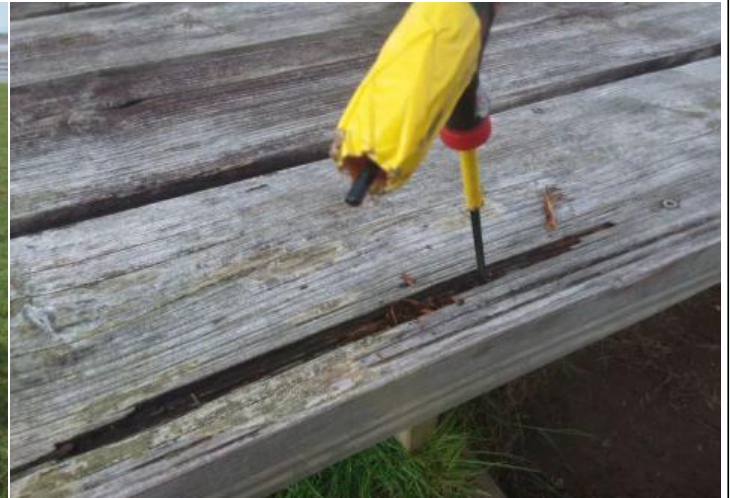
Item: Ancillary Items - Picnic Table
Manufacturer: Not Identified

Finding: There is some evidence of rot in the timber

Action: Monitor for any further deterioration and replace as required

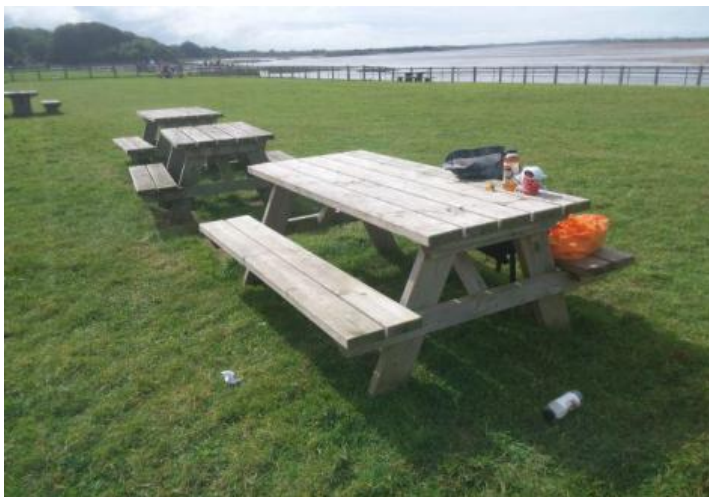
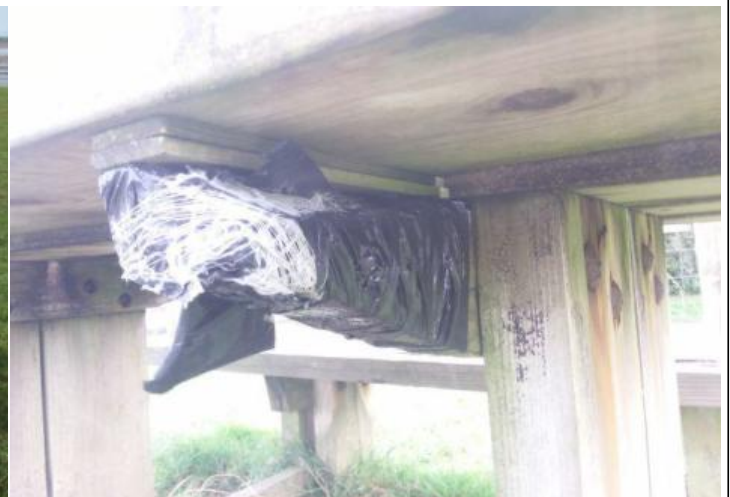
Item: Ancillary Items - Picnic Table
Manufacturer: Not Identified

Finding: Parts of this item have been taped and we are unable to fully assess the condition of the item

Action: Repair or replace as required

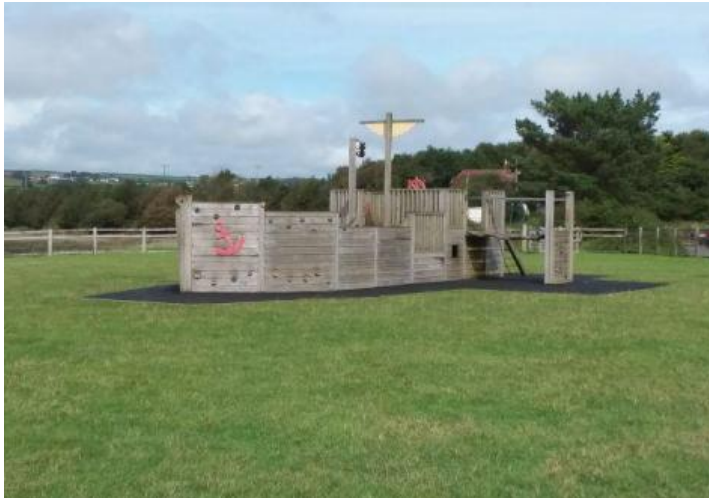
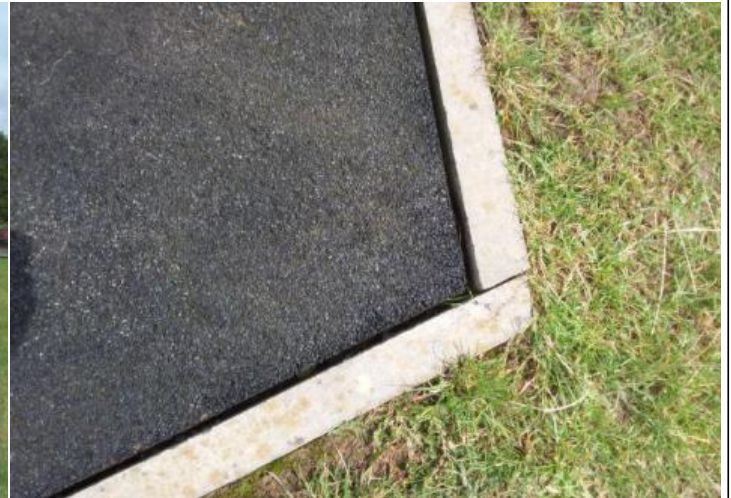
Item: Activity Equipment - Multi Play (Junior)
Manufacturer: Not Identified

Finding: There are gaps opening between the surfacing and the edging surround or between the joints in the surfacing
Action: Monitor for any further deterioration and repair as required

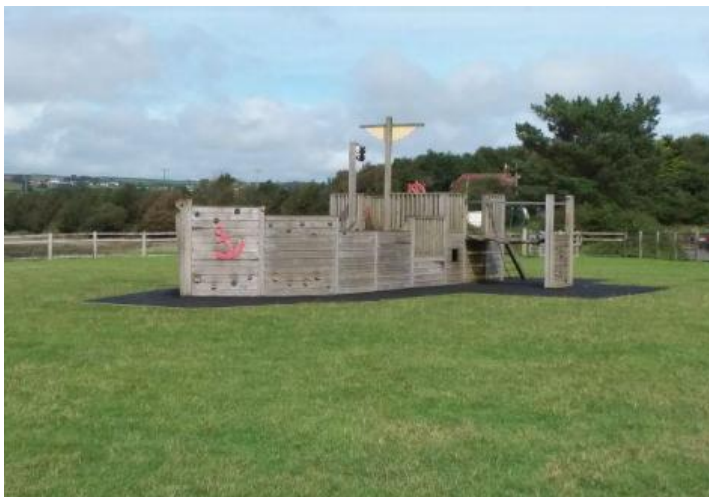
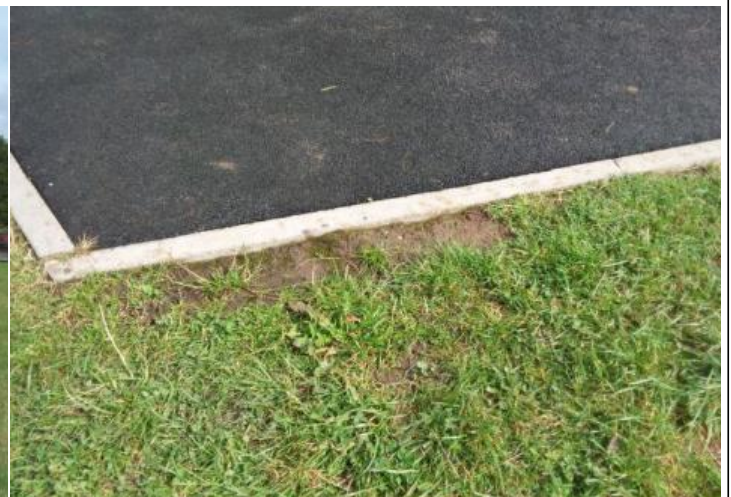
Item: Activity Equipment - Multi Play (Junior)
Manufacturer: Not Identified

Finding: There are trip hazards at the edges of the surface
Action: Reinstate surrounding surface levels to remove the trip points

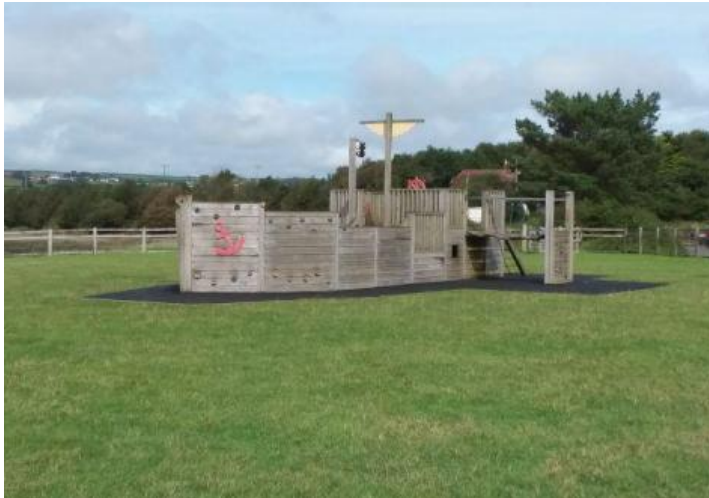
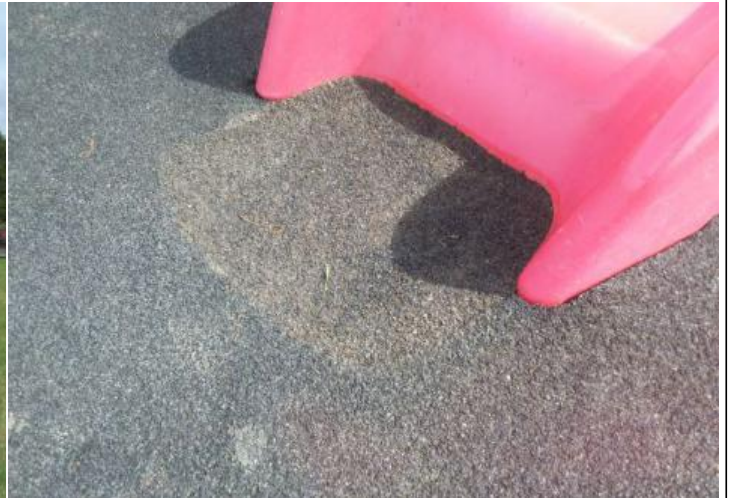
Item: Activity Equipment - Multi Play (Junior)
Manufacturer: Not Identified

Finding: The safety surface around the area is beginning to wear

Action: Monitor for any further deterioration and repair as required

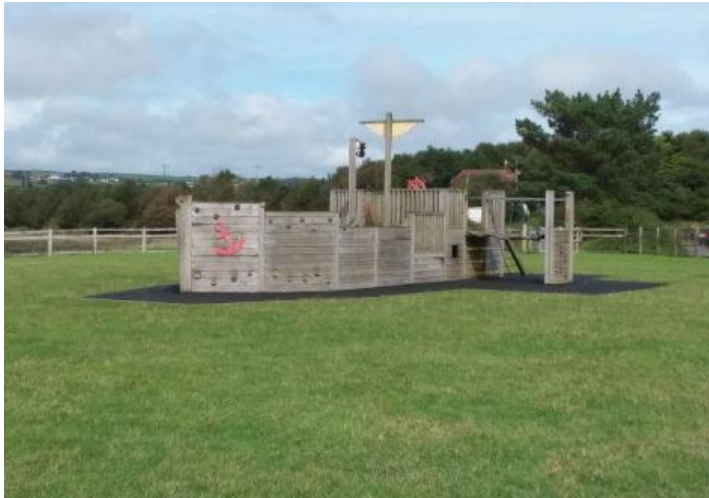
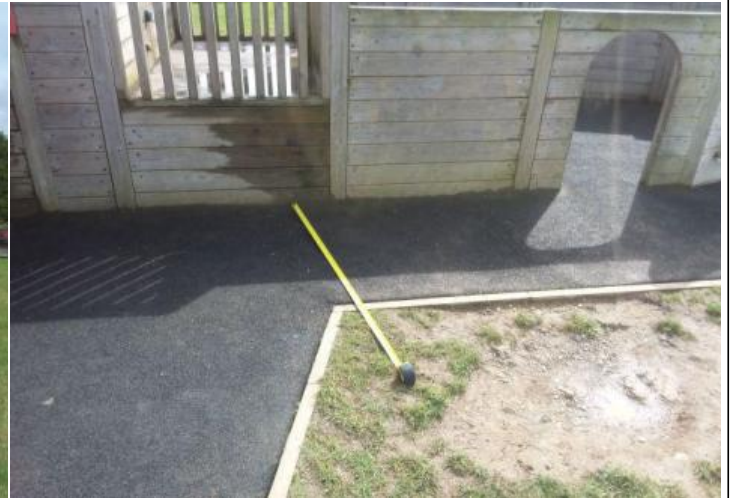
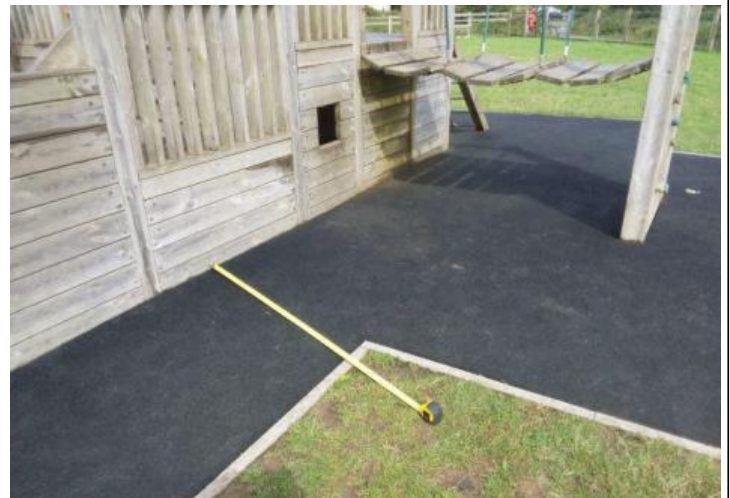
Item: Activity Equipment - Multi Play (Junior)
Manufacturer: Not Identified

Finding: The surfacing dimensions do not meet with the requirements of the current applicable standard

Action: We consider this to be a low risk finding and no remedial action is recommended - monitor use

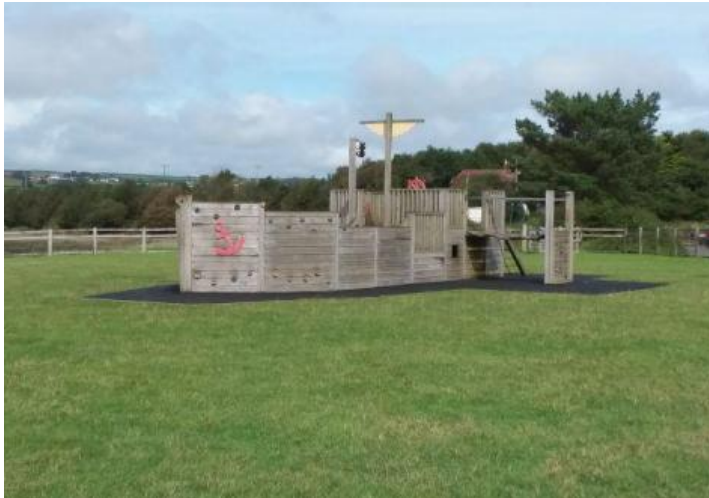
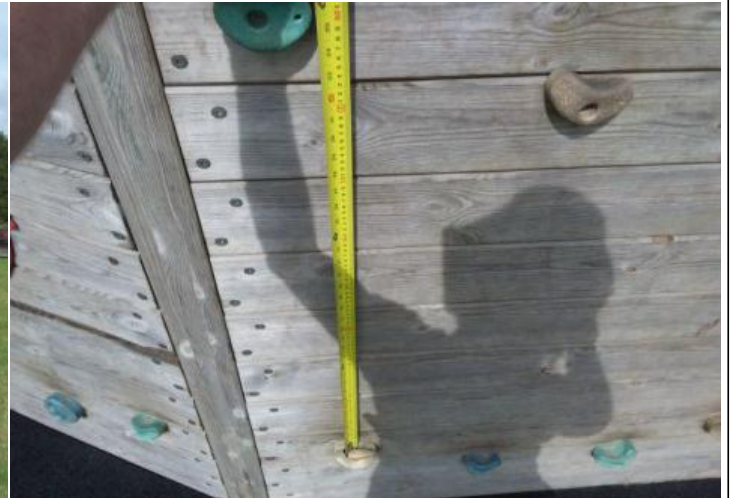
Item: Activity Equipment - Multi Play (Junior)
Manufacturer: Not Identified

Finding: The spacing between the hand and footholds on the traverse walls is less than the recommended minimum 1.0m and may encourage climbing

Action: Monitor use and adjust peg layout if required

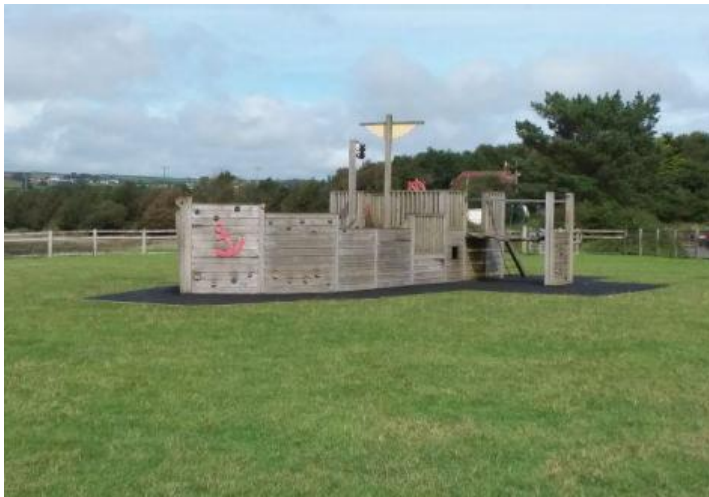
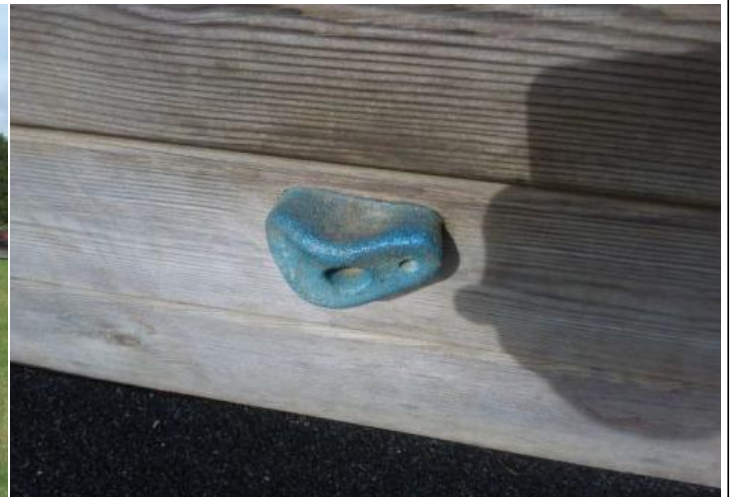
Item: Activity Equipment - Multi Play (Junior)
Manufacturer: Not Identified

Finding: A number of peg fixing(s) have worked loose

Action: Secure all loose fixings

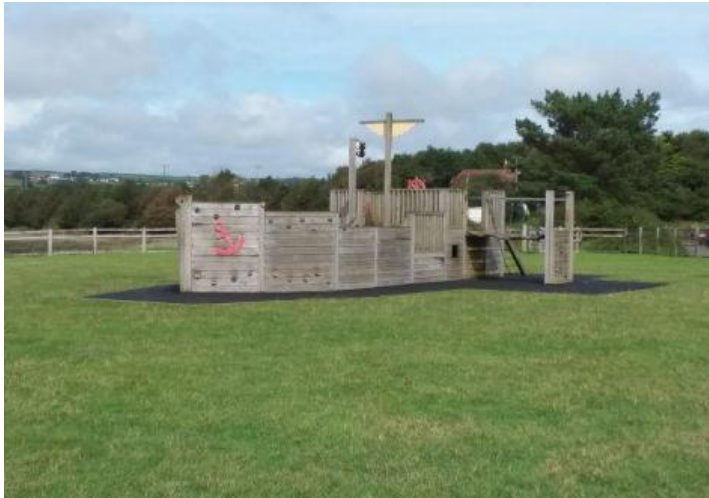
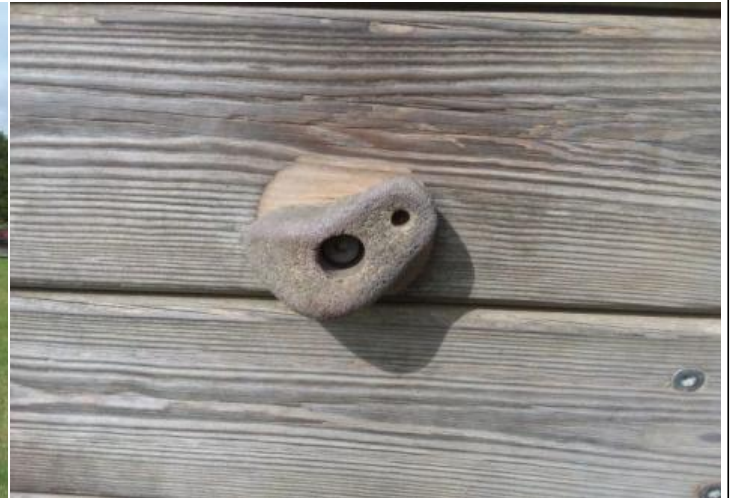
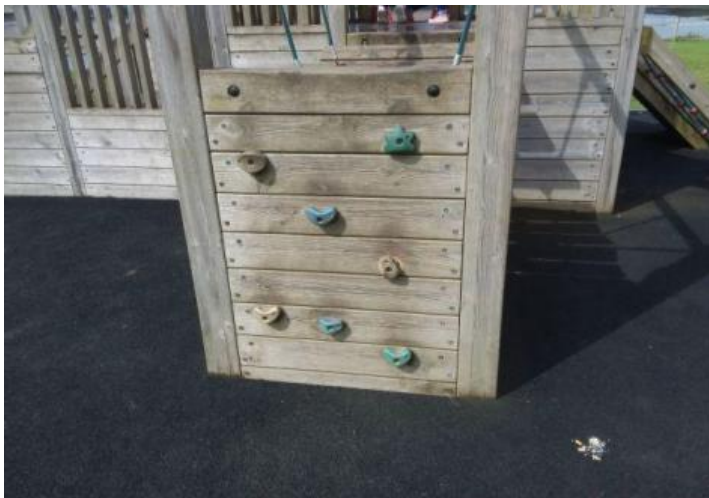
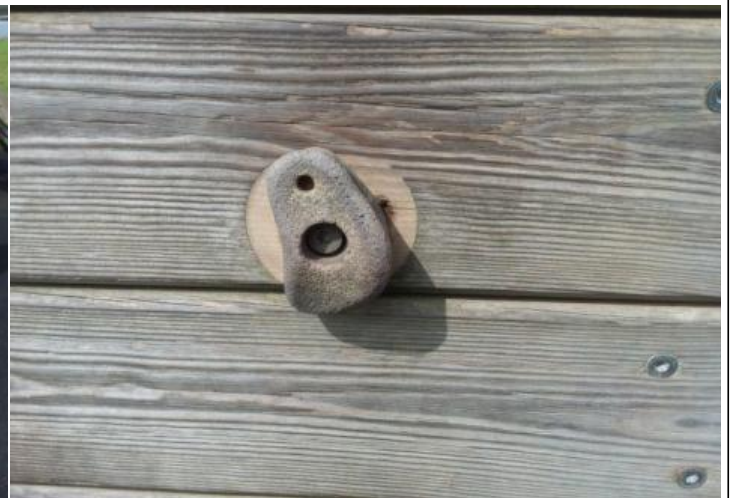
Item: Activity Equipment - Multi Play (Junior)
Manufacturer: Not Identified

Finding: There is or are fixings missing on the pegs and some of the pegs rotate

Action: Replace all missing fixings to prevent rotation

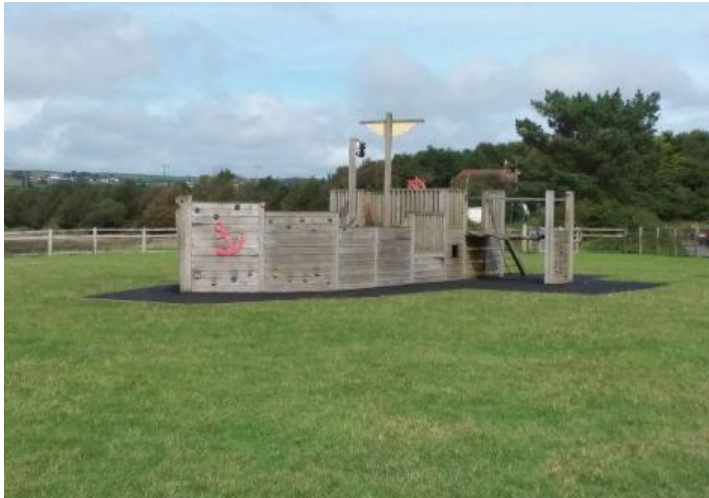
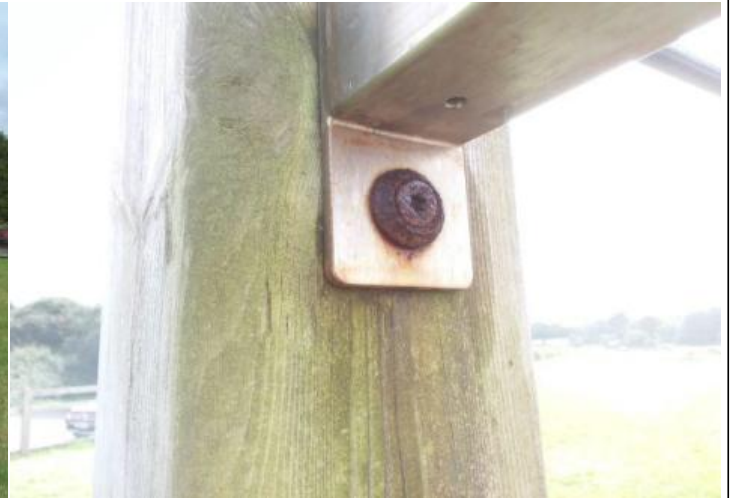
Item: Activity Equipment - Multi Play (Junior)
Manufacturer: Not Identified

Finding: A number of fixings are corroding

Action: Monitor for any further deterioration and replace as required

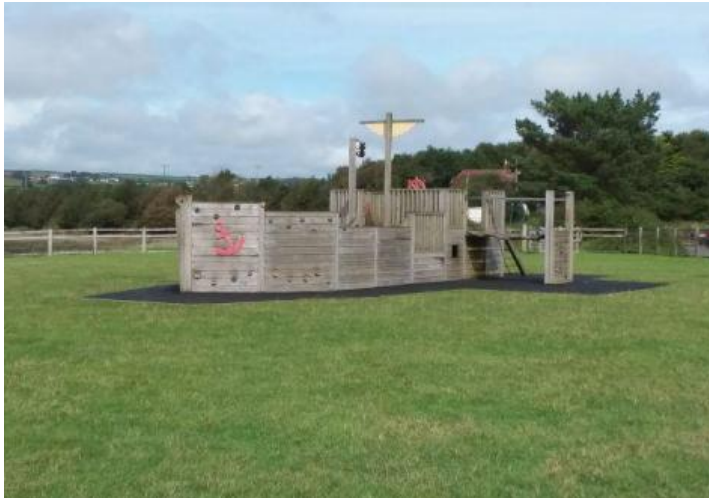
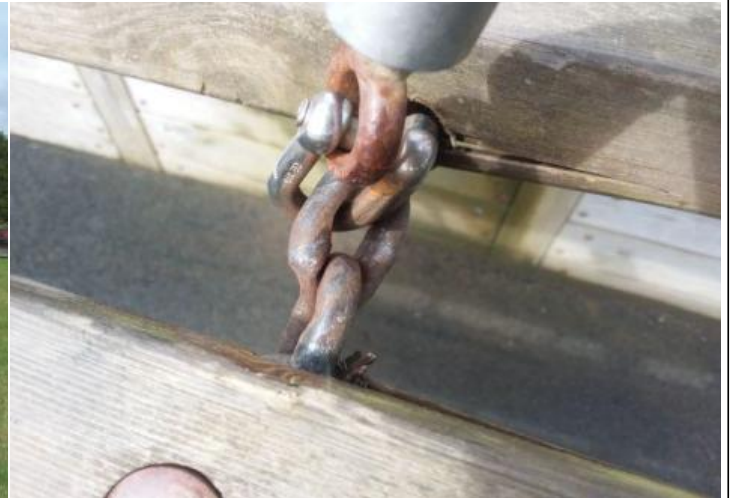
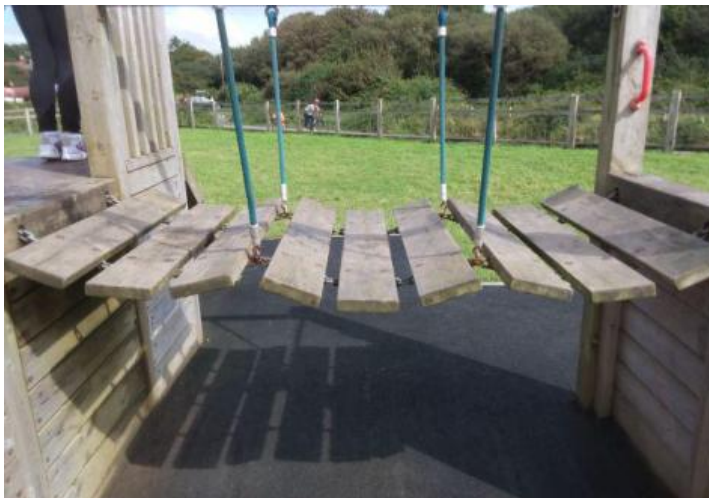
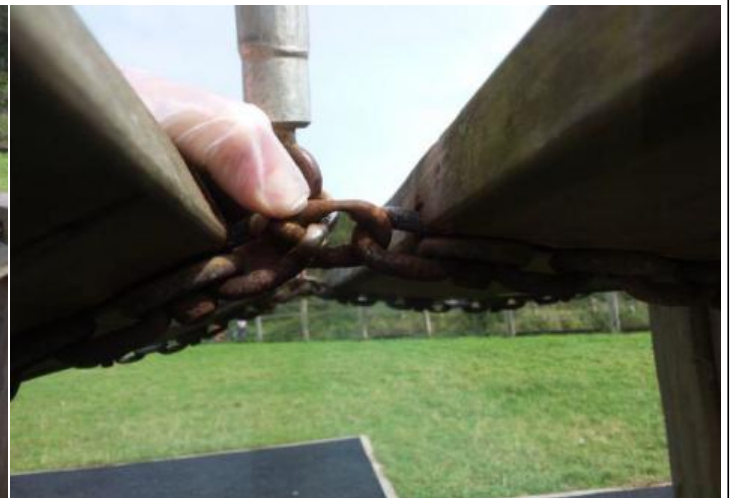
Item: Activity Equipment - Multi Play (Junior)
Manufacturer: Not Identified

Finding: Some of the chain links and bridge suspension components are worn in excess of 40% and require renewing

Action: Replace worn chains / links

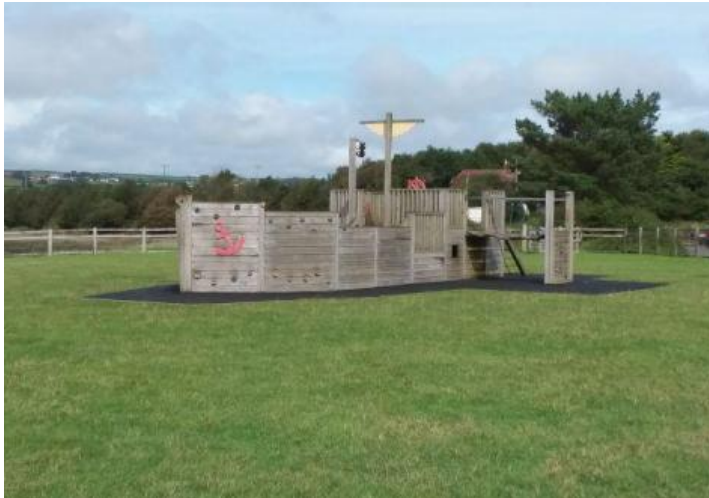
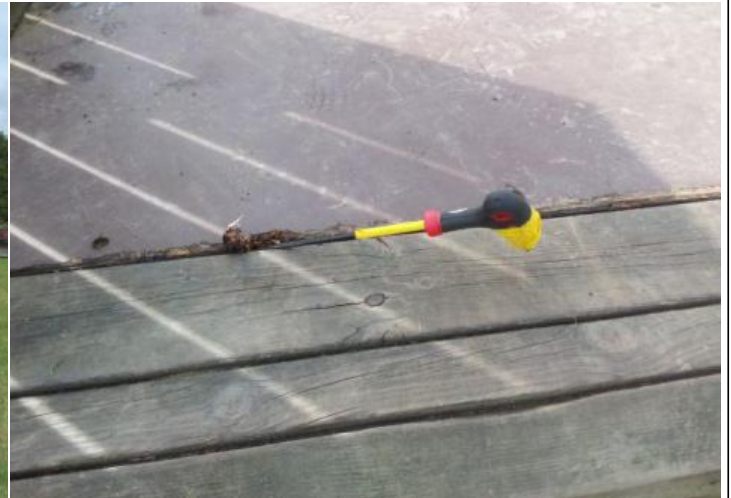
Item: Activity Equipment - Multi Play (Junior)
Manufacturer: Not Identified

Finding: There is some evidence of rot in the timber platforms

Action: Monitor for any further deterioration and replace as required
