Annual Inspection

Fremington Parish Council

Fremington Quay

Inspection Ref: 1172196

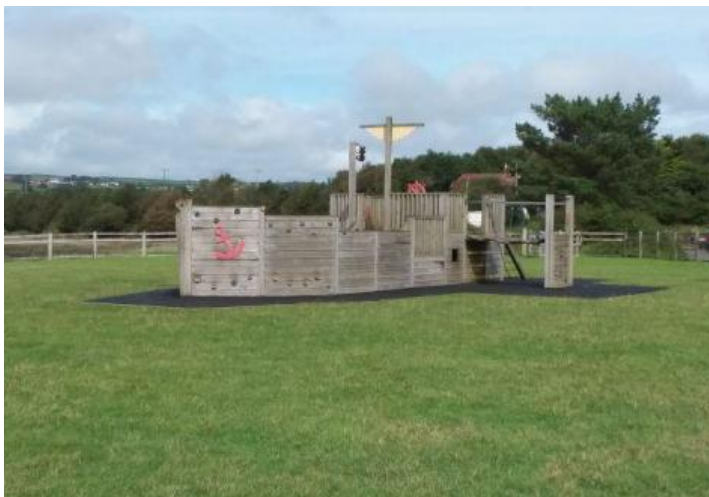
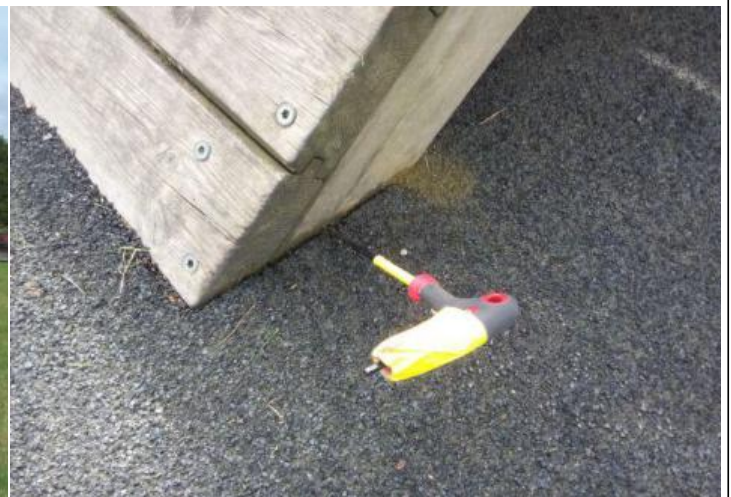
Item: Activity Equipment - Multi Play (Junior)
Manufacturer: Not Identified

Finding: There is some evidence of rot in the timber throughout

Action: Monitor for any further deterioration and replace as required

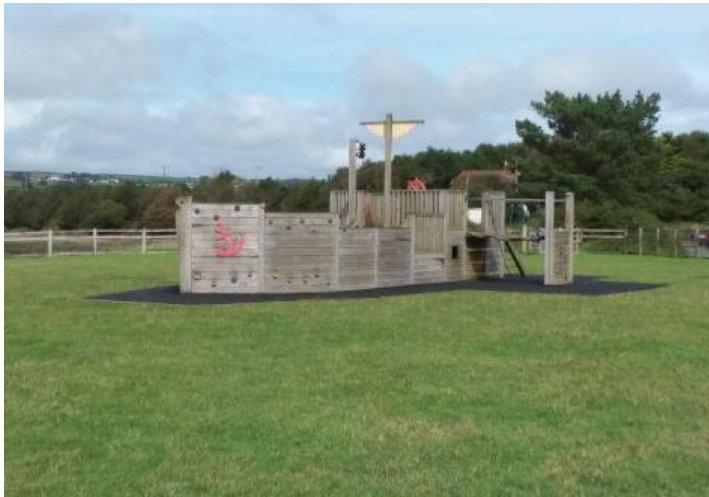
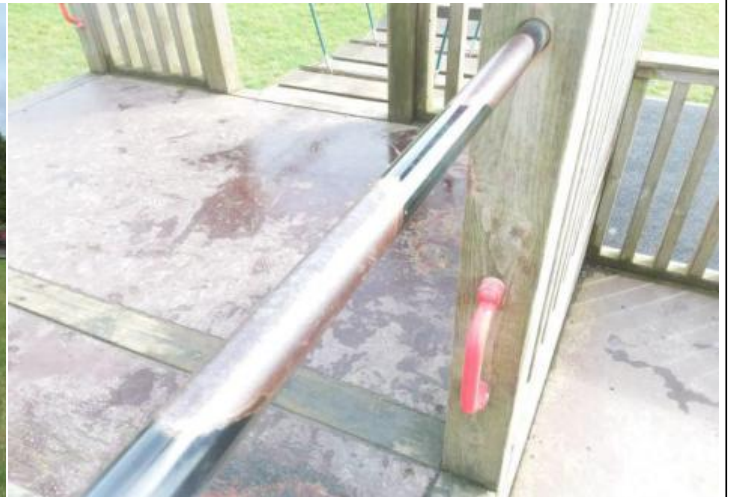
Item: Activity Equipment - Multi Play (Junior)
Manufacturer: Not Identified

Finding: There is surface corrosion present on the item

Action: Consider treating the item

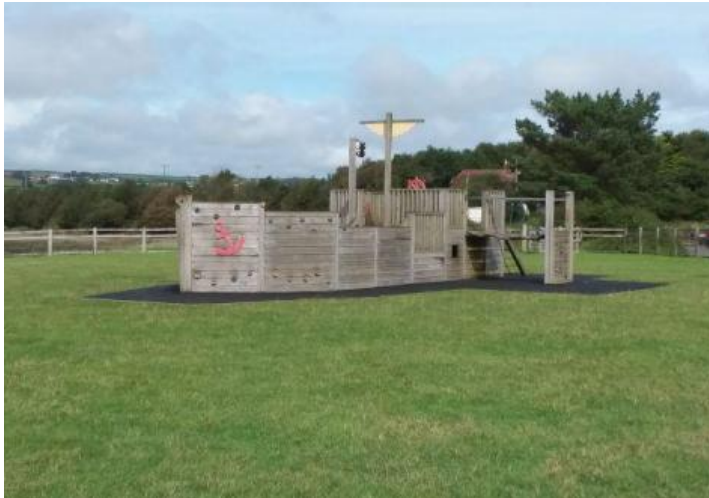
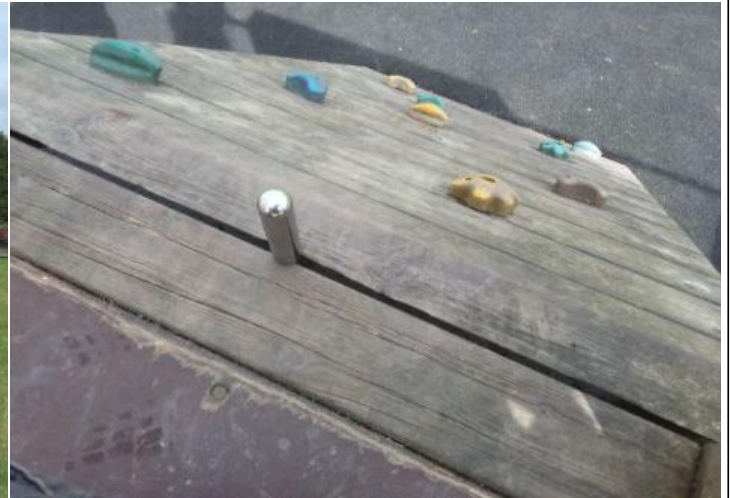
Item: Activity Equipment - Multi Play (Junior)
Manufacturer: Not Identified

Finding: There is/are finger entrapment/s in the top of the ramp and the item fails to meet the requirements of BS EN 1176 Part 1 4.2.7.6 Entrapment of fingers

Action: Monitor - No remedial work recommended

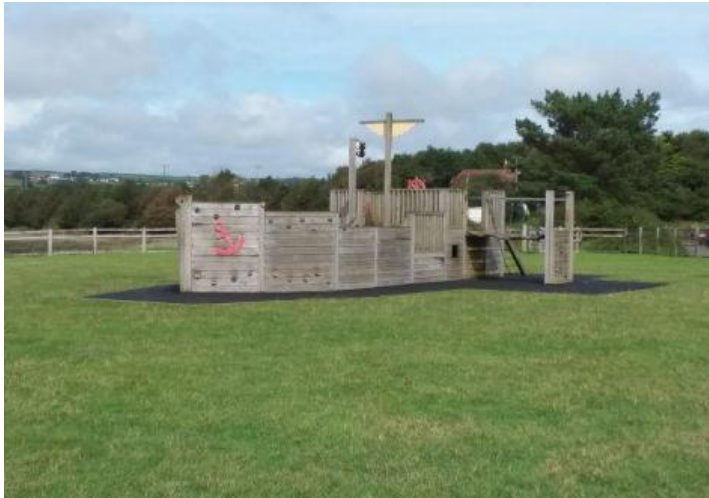
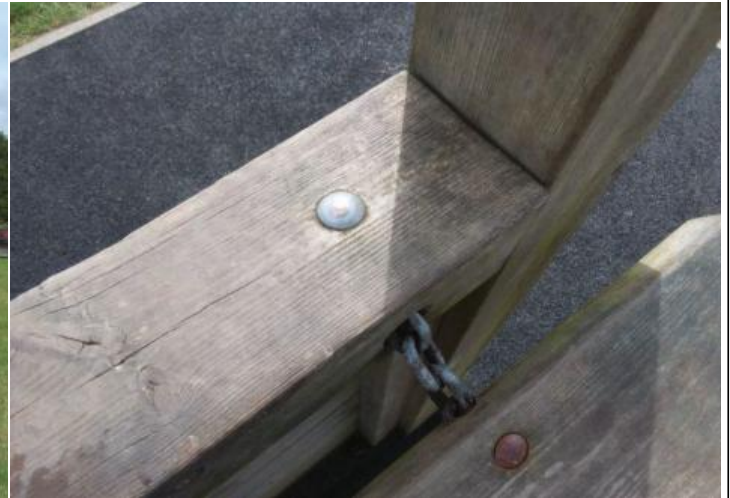
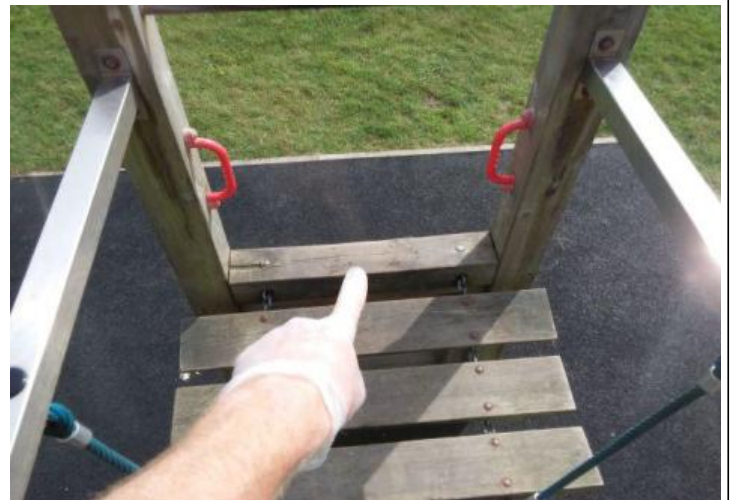
Item: Activity Equipment - Multi Play (Junior)
Manufacturer: Not Identified

Finding: A number of fixing(s) have worked loose and the bridge mount is loose

Action: Secure all loose fixings to secure the mount
