FREMINGTON PARISH COUNCIL

Review on the Sports Pitches at Tews Lane

Report Date: 9th October 2020

Visit Objective: To undertake an inspection of the pitches at Tews Lane and provide recommendations.

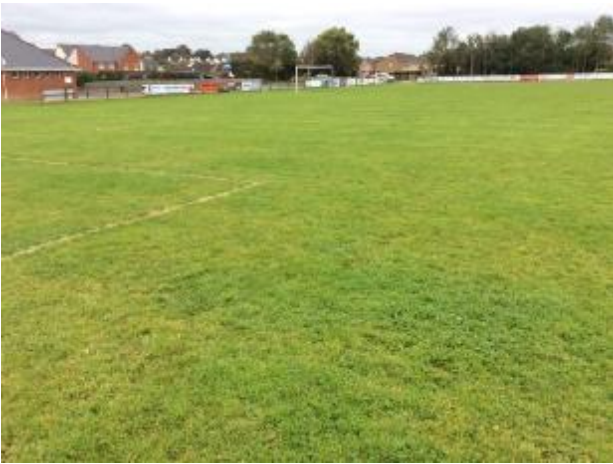
Figure 1: The site was inspected on a wet day following a dry period. There was no standing water but water was being held in the surface. There was 2 full sized and 1 junior pitches on site.

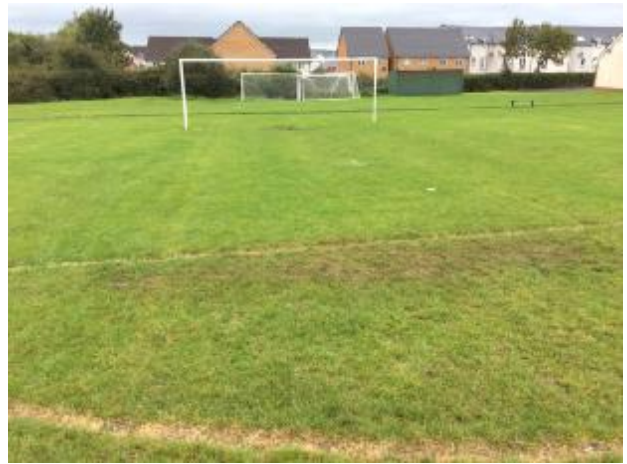
Figure 2: The grass cover was on average around 90% but bare ground was noted in the goalmouths and the central portions weaker and thinner. There was evidence of intensive training or casual use in the higher wear areas.

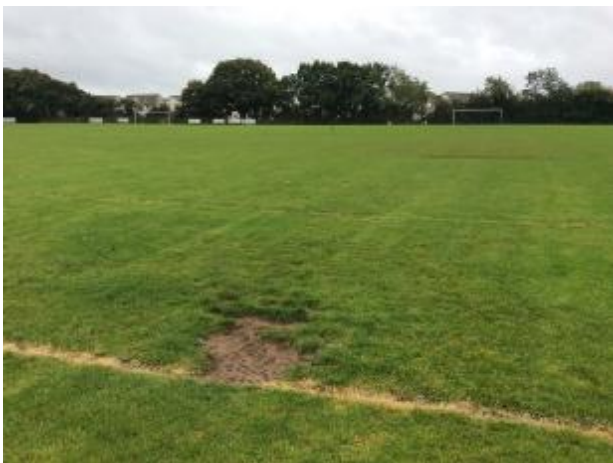
Figure 3: The goals were unrepaired and most were bare and dipped. The grass height varied between 45-60mm. There were areas of poor grass cutting visible as a stripe.

- The existing maintenance appeared to have been using a higher height of cut than the 30mm specified although this is probably a little short, ideally around 40mm would be maintained. In places some areas were up to 60mm. The quality of cut was slightly poor and looked like one unit or part of a unit was scalping the surfaces slightly.

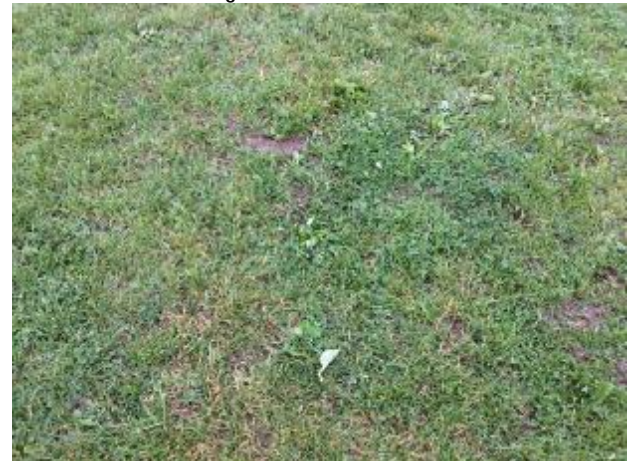
Figure 4: The grass cover was mainly turf ryegrasses and some meadow grasses. There was a moderate weed content of clover, plantains (indicating compaction) and dandelion.

- There was no evidence of any weed treatment being undertaken and whilst the conditions are becoming cooler and the treatment is less effective there is still time in the south for such treatments to be appropriate.

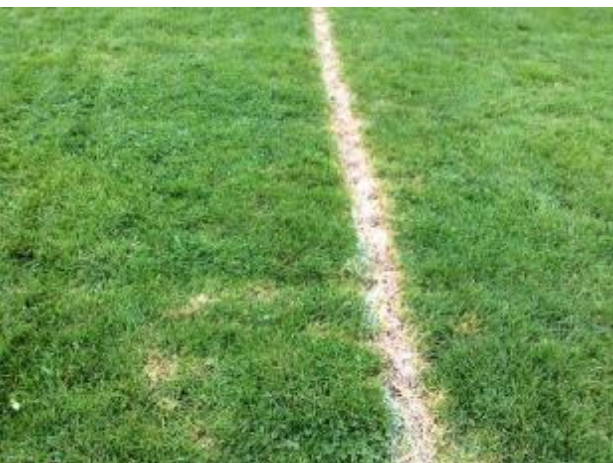
Figure 5: The white lines appeared to have been "herbiced in" probably using glyphosate and this has crept beyond the line in places. Whilst this is a fairly common occurrence it is not deemed to be good practice. The individual product would need to have an approval for this use.

- The white line marking does not include the use of any herbicides within the mix. It would appear potentially that Glyphosate has been used in the marking mix. Whilst this is a common practice, it would not be deemed as best practice and any product that is mixed with the line marking fluid must be approved for that purpose. There is also a significant risk with Glyphosate that the line creeps and there was evidence of some footprints where Glyphosate had been picked up on the foot and then walked across the grass effectively killing it. Also long term use will result in significant crack occurring along the lines and some sites have reported significant trip hazards being caused. The use of effective white lining materials and on a sufficient frequency will preserve a good line.

- The weed control was used on kerb edges but has crept significantly into grassed areas. This again would be deemed to be a relatively poor practice and should not occur in the future.

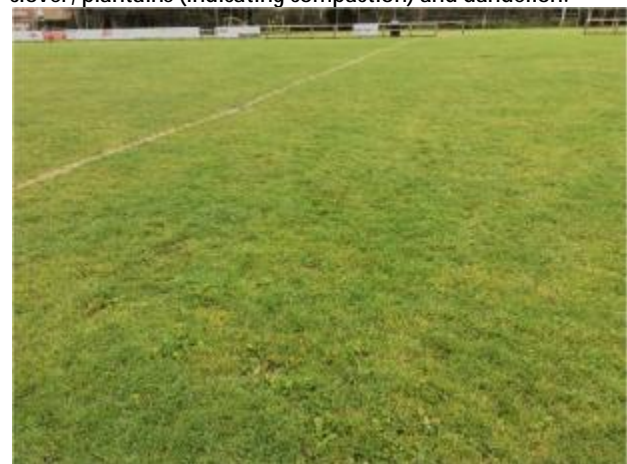
Figure 6: The general levels across the pitches were satisfactory with the worst pitch being closest to the road (eastern). There was a lengthways slope downwards to the north. It was estimated to be 1 in 50. If the case this would be outside the current lengthways guidelines. This would need to be confirmed.

- The levels across the site were within tolerances for a reasonable quality surface. However, the pitch lengthwise fall to the north was estimated to be around 1:50 but would fall outside the 1:80 recommended level. However, this would need to be checked with a survey of the site potentially. It would not however be recommended for a releveling of the site to occur as it is relatively constrained and the soils would present a number of risks.

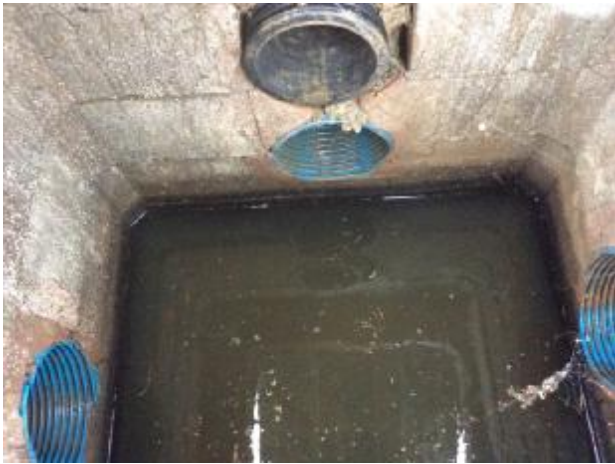
Figure 7: The North western pitch side manhole was loose and damaged. It was lifted slightly to allow a photograph to be taken. There were a number of inlets and outfall. There was only one in a west direction that showed an evidence of water flow. The middle south pipe was investigated in figure 8.

- The manholes on site were a non-lockable light steel type and were being displaced. Even if no further works occur then these should be replaced with heavy duty types and possibly be buried with the location recorded.

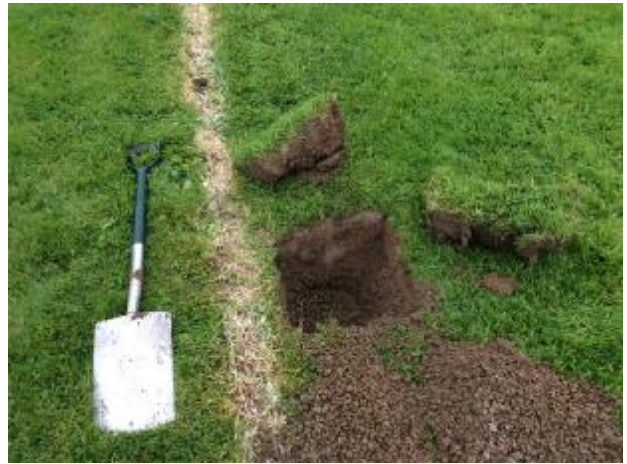
Figure 8: The main drain was dug and the aggregate. There was a layer of 100mm of topsoil over the aggregate which was found to be significantly blocked with soil in the upper 100mm. Below this the aggregate was cleaner.

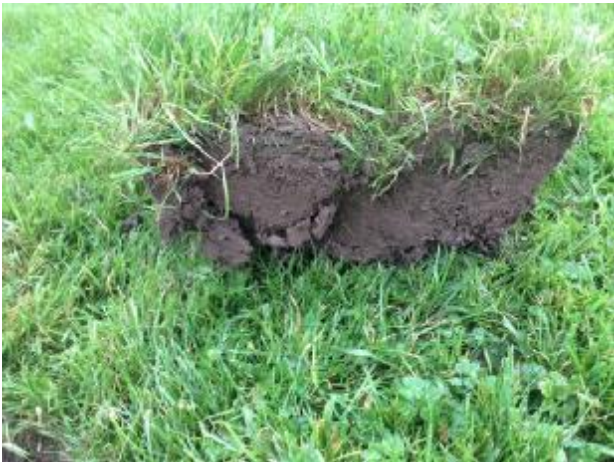
Figure 9: No drains were visible or found in the pitch. In STRI reports in 2006 and 2010 it was reported the drainage was installed under the topsoil. The drainage therefore would not be seen on the surface, would not be effective in the heavy soils and without secondary drainage. The soil was heavy and stone rich below 60mm. Rooting was good.

- Despite probing the surface extensively no drainage aggregate could be located in the upper 150mm and no evidence was seen on the surface as typically occurs. The outfall appeared to be flowing well but the route could not be determined. It may exist into the surface water run off system.

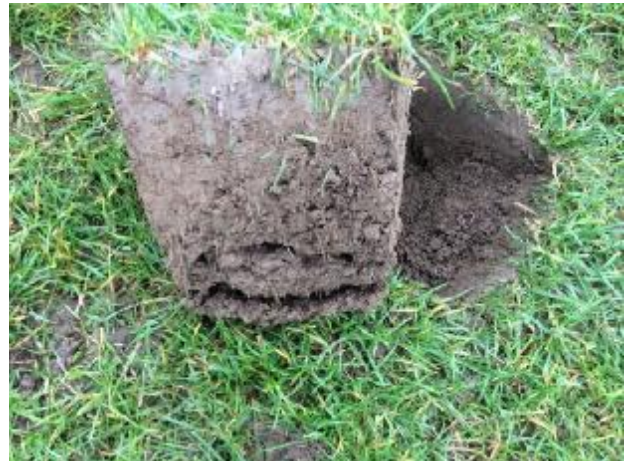
Figure 10: The pitch centres were more compact as shown above with a smeared layer. There was no evidence of sand dressings or secondary drainage installation.

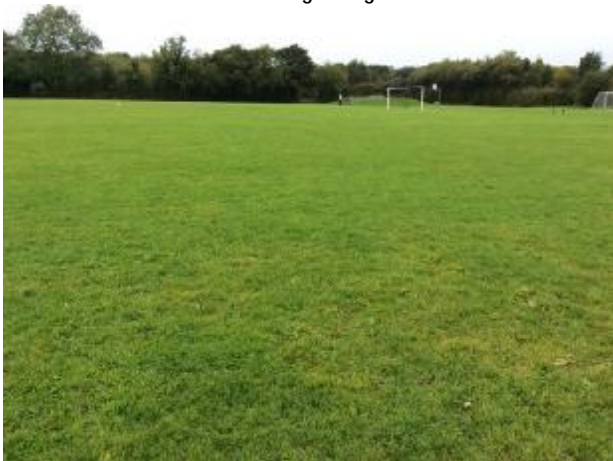
Figure 11: The grass health was variable with weak thin areas in area of high wear.

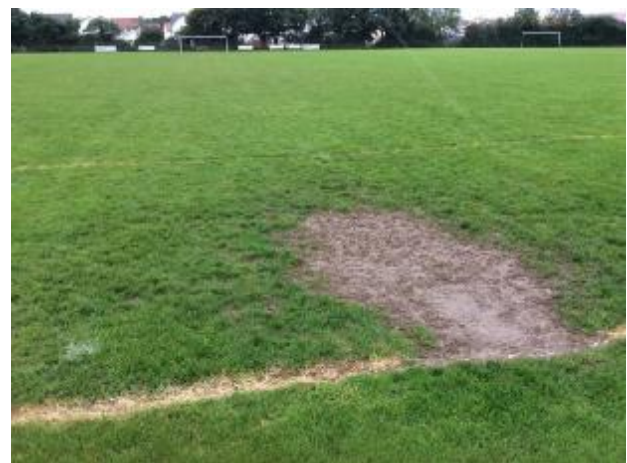
Figure 12: Wear in the eastern pitch goal at the North end. Note the creep in the white line.
