Annual Inspection

Fremington Parish Council

Fremington Quay

Inspection Ref: 1172196

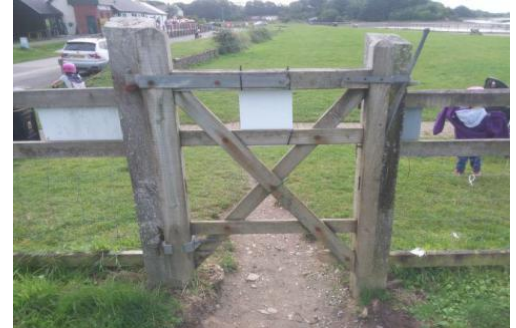
Item: Gate - Pedestrian
Manufacturer: Not Identified
Surface Type: Grass
Item Quantity: 1
Equipment Compliance: N/A
Surface Area Compliance: N/A

The area under the gate has eroded leaving uneven areas, or the concrete foundations exposed, resulting in trip hazards at the entrance/exit to the playground - Reinstate to level with surrounding surfaces

The gate is damaged - Repair as required

A number of fixing(s) have worked loose - Secure all loose fixings

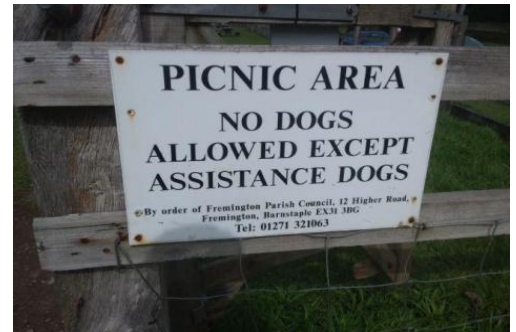
Item: Sign
Manufacturer: Owner/Operator
Surface Type: N/A
Item Quantity: 1
Equipment Compliance: N/A
Surface Area Compliance: N/A

It is recommended that signage, with information including the site address, contact information for maintenance issues and emergency contact details are provided for the facility - Provide in accordance with the recommendations

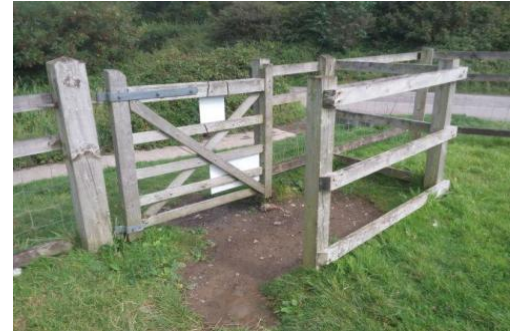
Item: Kissing Gate
Manufacturer: Not Identified
Surface Type: Grass
Item Quantity: 1
Equipment Compliance: N/A
Surface Area Compliance: N/A

The item is loose in its foundations - Reinstall item to secure

Two posts have rotted and sheared - Replace

The area under the gate has eroded leaving uneven areas, or the concrete foundations exposed, resulting in trip hazards at the entrance/exit to the playground - Reinststate to level with surrounding surfaces

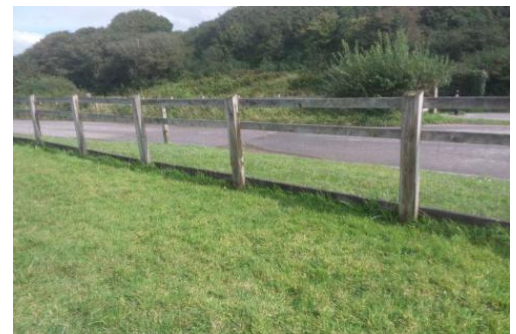
Item: Fence - Timber & Mesh Infill
Manufacturer: Not Identified
Surface Type: Grass
Item Quantity: 1
Equipment Compliance: N/A
Surface Area Compliance: N/A

There are a number of loose posts around the fence - Monitor for any further deterioration and reset as required

A number of posts have rotted and sheared - Replace

There is some damage to the fence sections - Monitor for any further deterioration and repair as required

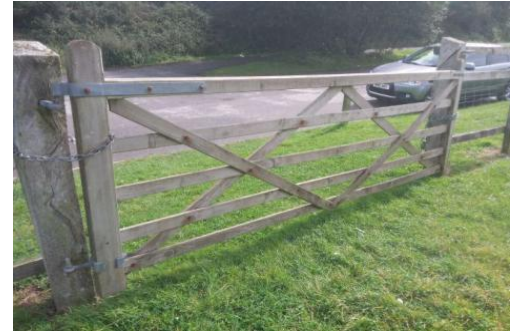
Item: Gate - Maintenance
Manufacturer: Not Identified
Surface Type: Grass
Item Quantity: 1
Equipment Compliance: N/A
Surface Area Compliance: N/A

The post has rotted and sheared - Replace

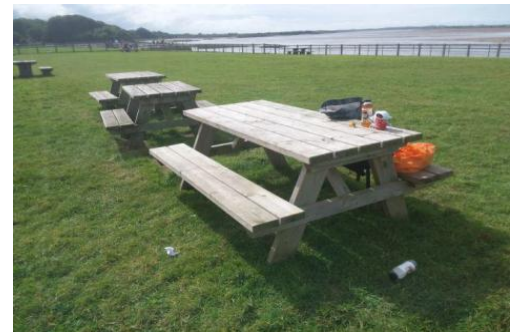
Item: Picnic Table
Manufacturer: Not Identified
Surface Type: Grass
Item Quantity: 1
Equipment Compliance: N/A
Surface Area Compliance: N/A

There are areas or parts of the timber on the structure that have rotted - Replace all affected timbers

There is some evidence of rot in the timber - Monitor for any further deterioration and replace as required

Parts of this item have been taped and we are unable to fully assess the condition of the item - Repair or replace as required

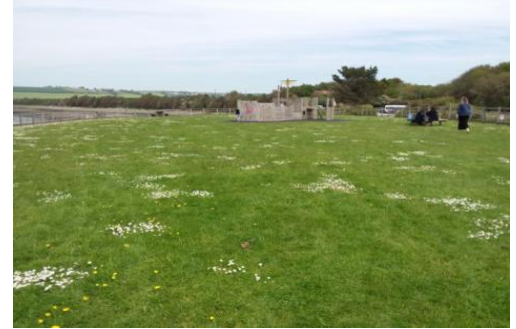
Item: Site General
Manufacturer: Owner/Operator
Surface Type: N/A
Item Quantity: 1
Equipment Compliance: N/A
Surface Area Compliance: N/A

The site is accessible to the public during the COVID 19 pandemic. The government have released guidelines for safely re-opening these types of facilities which is available on the government website. - Ensure there is an appropriate risk assessment in place and review regularly

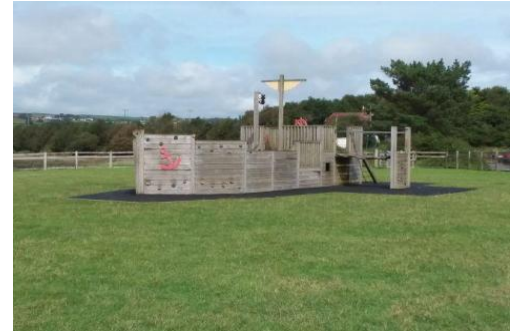
Item: Multi Play (Junior)
Manufacturer: Not Identified
Surface Type: Wet Pour
Item Quantity: 1
Equipment Compliance: No
Surface Area Compliance: No

There are gaps opening between the surfacing and the edging surround or between the joints in the surfacing - Monitor for any further deterioration and repair as required

The safety surface around the area is beginning to wear - Monitor for any further deterioration and repair as required

The spacing between the hand and footholds on the traverse walls is less than the recommended minimum 1.0m and may encourage climbing - Monitor use and adjust peg layout if required

There is or are fixings missing on the pegs and some of the pegs rotate - Replace all missing fixings to prevent rotation

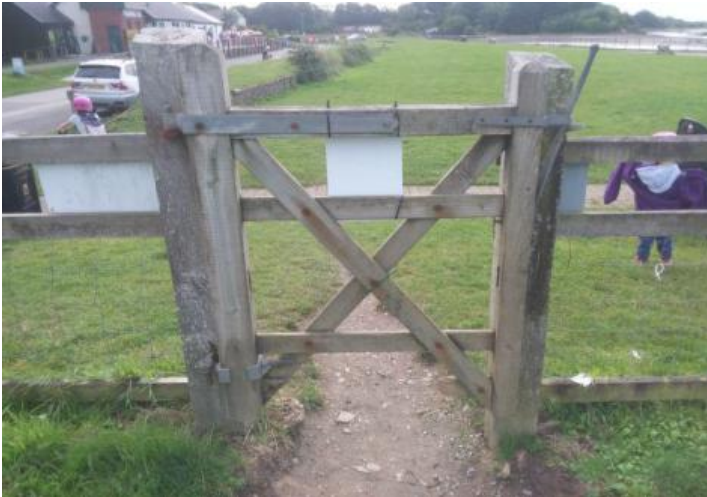
Item: Ancillary Items - Gate - Pedestrian
Manufacturer: Not Identified

Finding: The area under the gate has eroded leaving uneven areas, or the concrete foundations exposed, resulting in trip hazards at the entrance/exit to the playground

Action: Reinststate to level with surrounding surfaces

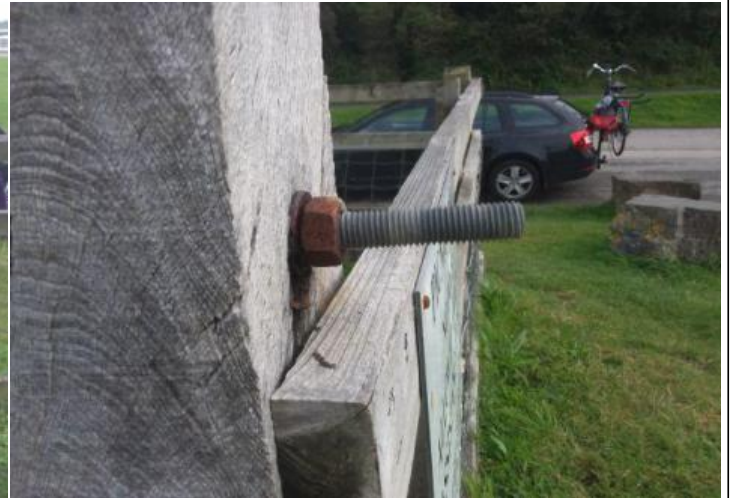
Item: Ancillary Items - Gate - Pedestrian
Manufacturer: Not Identified

Finding: There are projecting bolt thread(s) present

Action: Remove excess thread length and deburr or provide cap

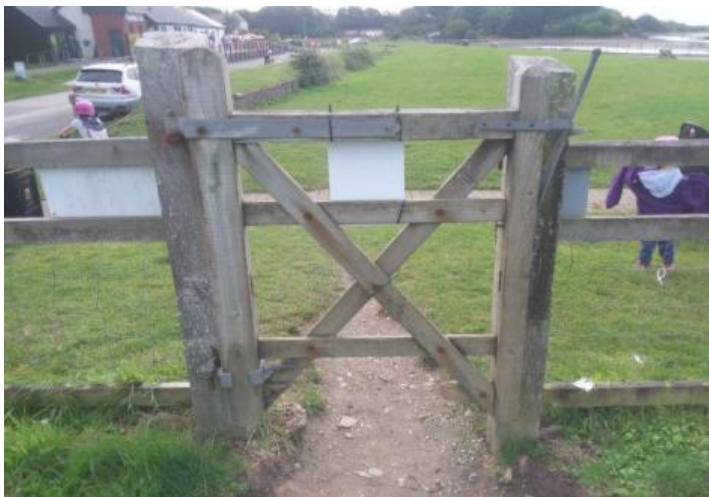
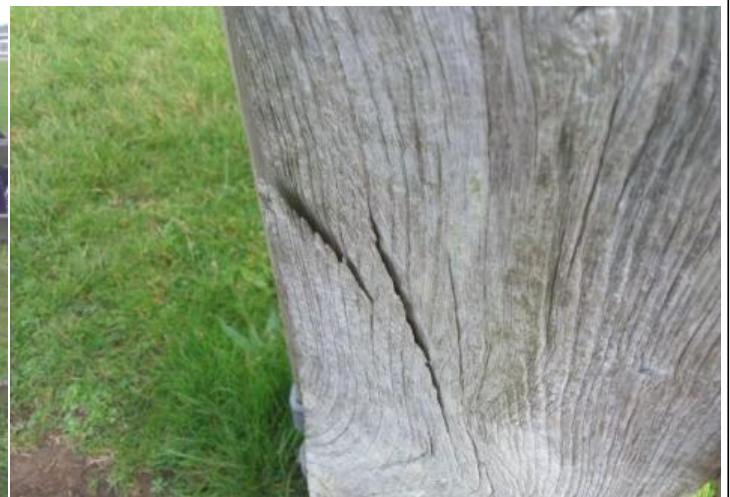
Item: Ancillary Items - Gate - Pedestrian
Manufacturer: Not Identified

Finding: Parts of the timber are rough or splintered

Action: Remove all rough or sharp edges

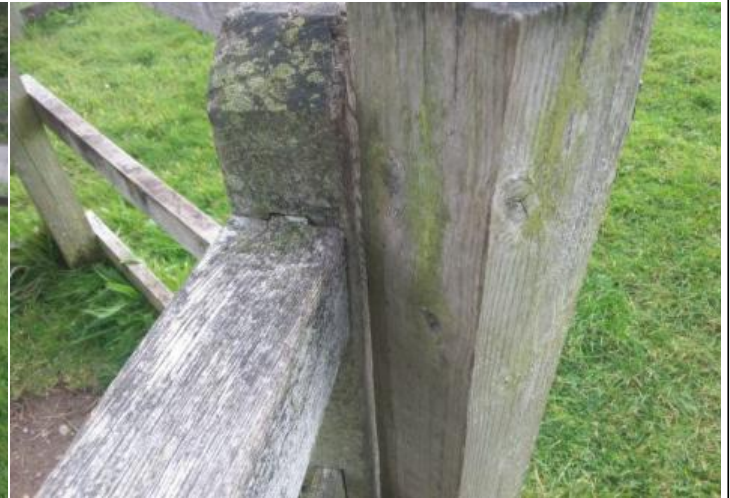
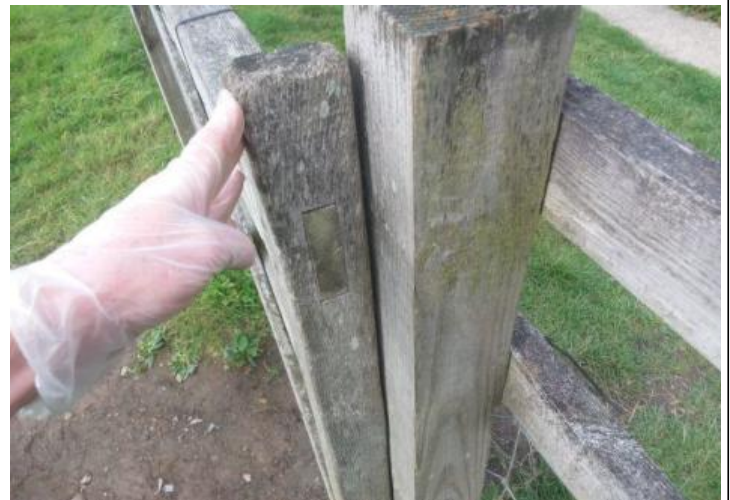
Item: Ancillary Items - Kissing Gate
Manufacturer: Not Identified

Finding: There are openings that are less than 12mm that could trap or crush fingers

Action: Where possible a 12mm gap should be maintained on both sides or between the gate leaves

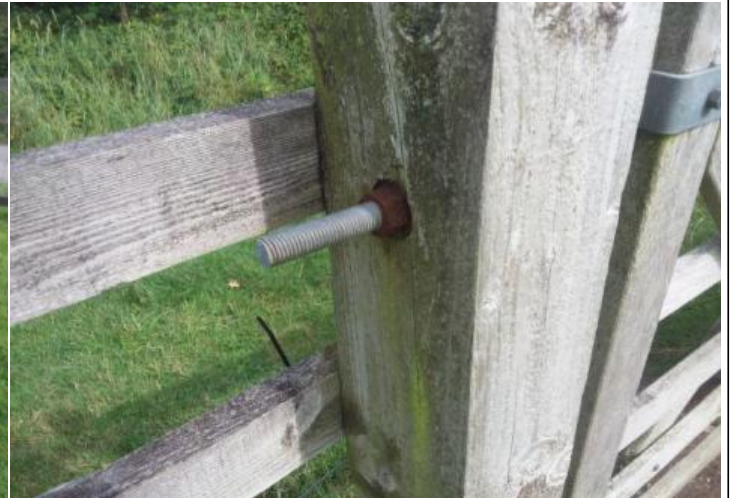
Item: Ancillary Items - Kissing Gate
Manufacturer: Not Identified

Finding: There are projecting bolt thread(s) present

Action: Remove excess thread length and deburr or provide cap

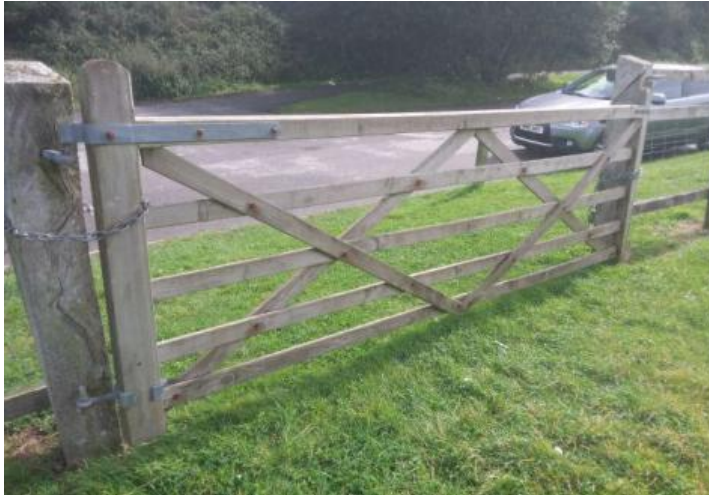
Item: Ancillary Items - Gate - Maintenance
Manufacturer: Not Identified

Finding: The post has rotted and sheared

Action: Replace

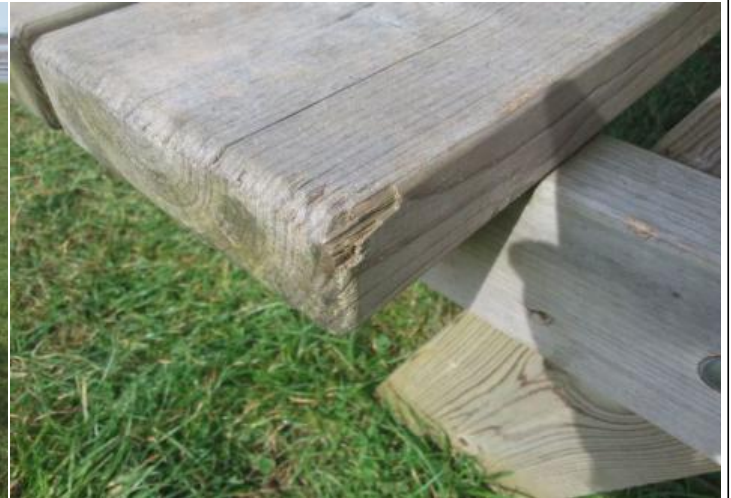
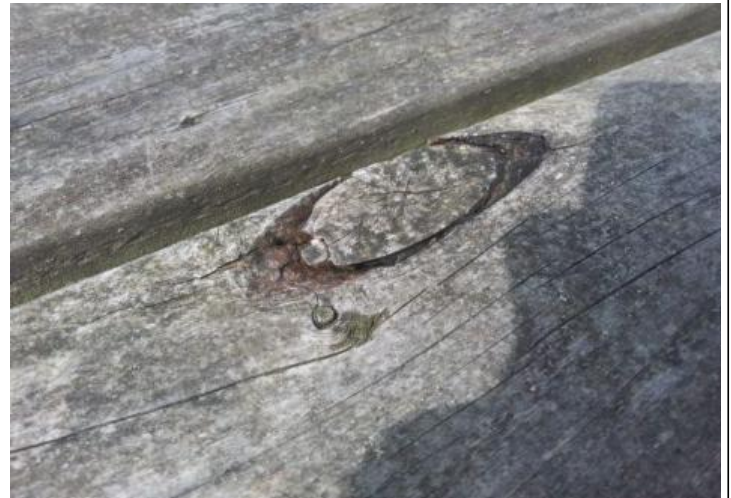
Item: Ancillary Items - Picnic Table
Manufacturer: Not Identified

Finding: Parts of the timber are rough or splintered

Action: Remove all rough or sharp edges

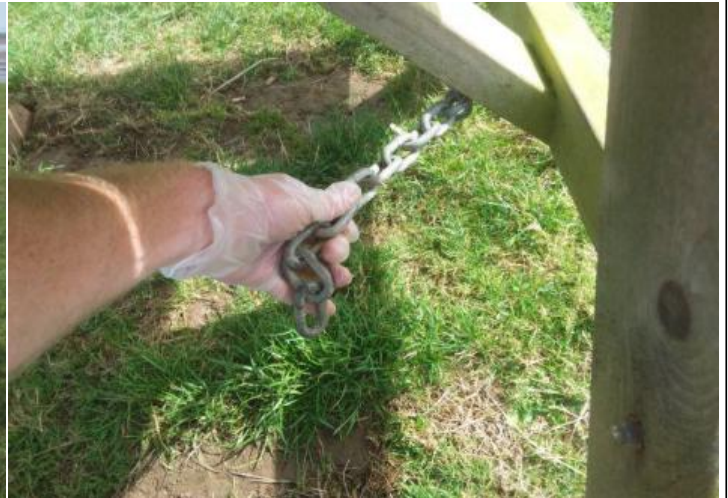
Item: Ancillary Items - Picnic Table
Manufacturer: Not Identified

Finding: The table is not secured to the ground and there is some potential for the item to be moved within falling spaces of equipment
Action: Secure the item to the ground

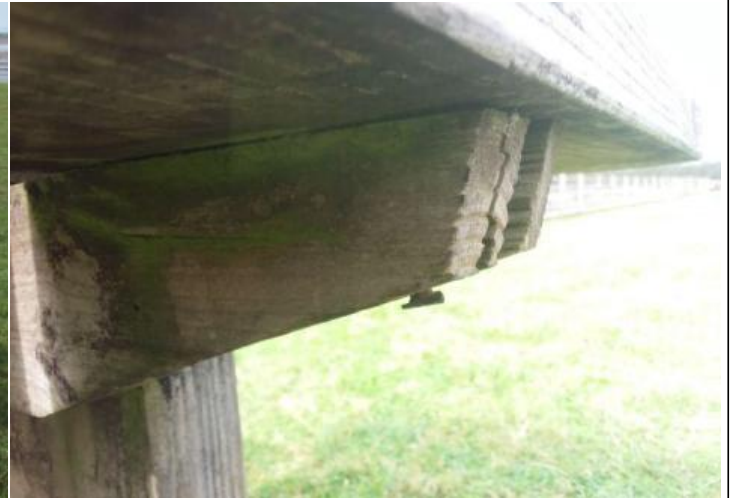
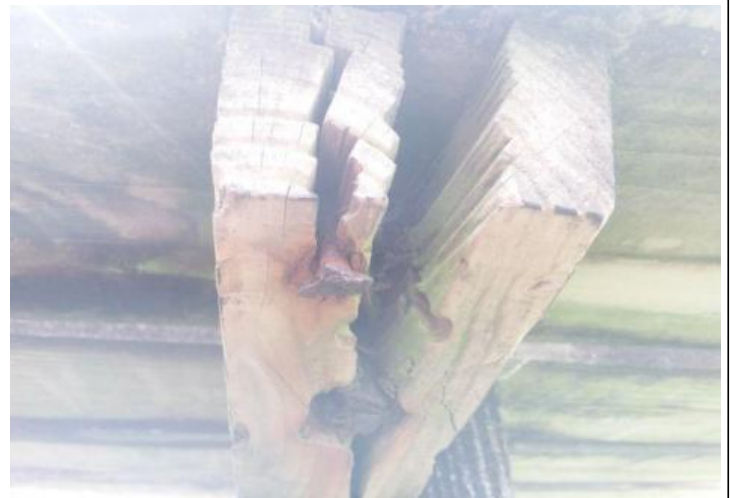
Item: Ancillary Items - Picnic Table
Manufacturer: Not Identified

Finding: There are projecting fixings present

Action: Remove or secure to remove the projections

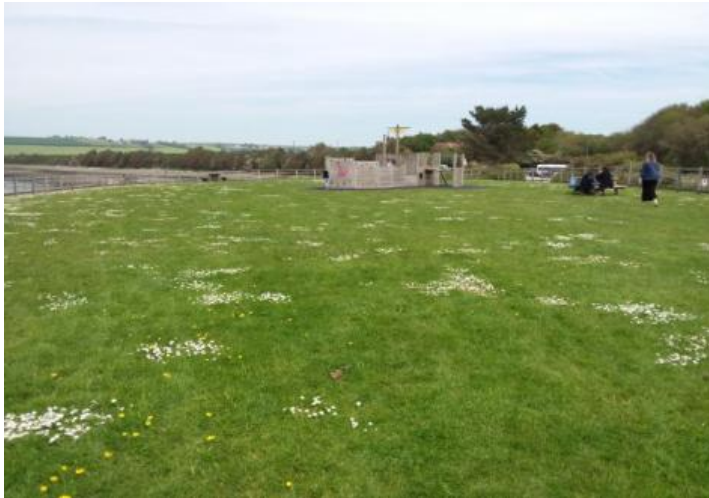
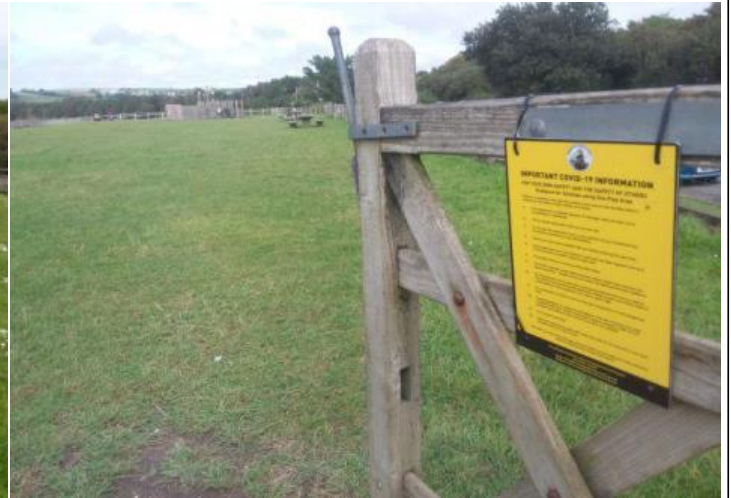
Item: Ancillary Items - Site General
Manufacturer: Owner/Operator

Finding: The site is accessible to the public during the COVID 19 pandemic. The government have released guidelines for safely re-opening these types of facilities which is available on the government website.

Action: Ensure there is an appropriate risk assessment in place and review regularly

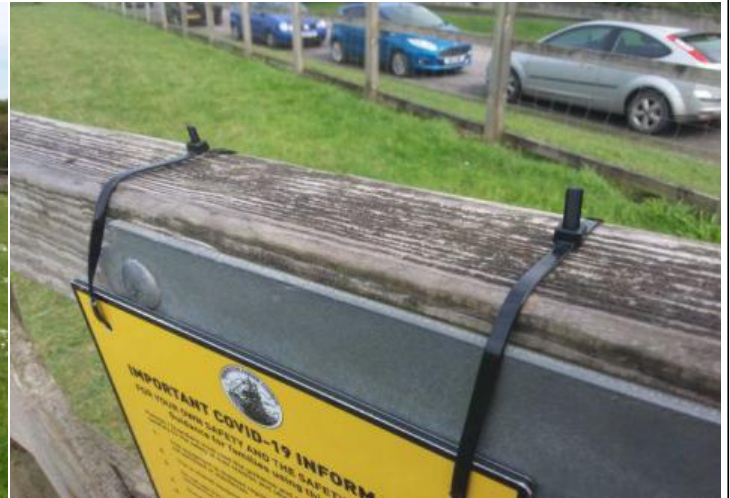
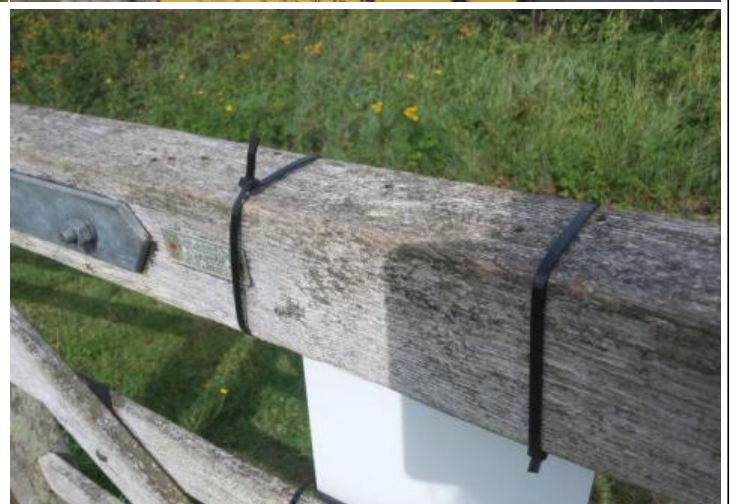
Item: Ancillary Items - Site General
Manufacturer: Owner/Operator

Finding: There are projecting cable ties present

Action: Remove excess lengths

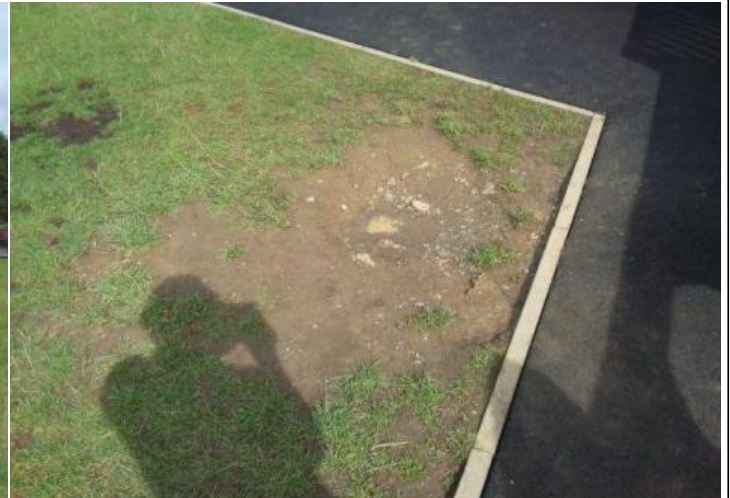
Item: Activity Equipment - Multi Play (Junior)
Manufacturer: Not Identified

Finding: The surface has eroded in some areas creating trip points
Action: Reinstate the surface

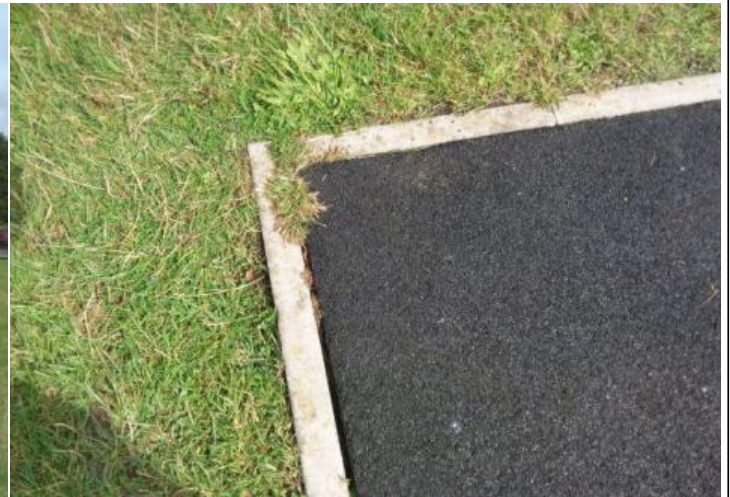
Item: Activity Equipment - Multi Play (Junior)
Manufacturer: Not Identified

Finding: There are weeds/vegetation growth between or around the edges of the surfacing
Action: Remove weeds/vegetation growth

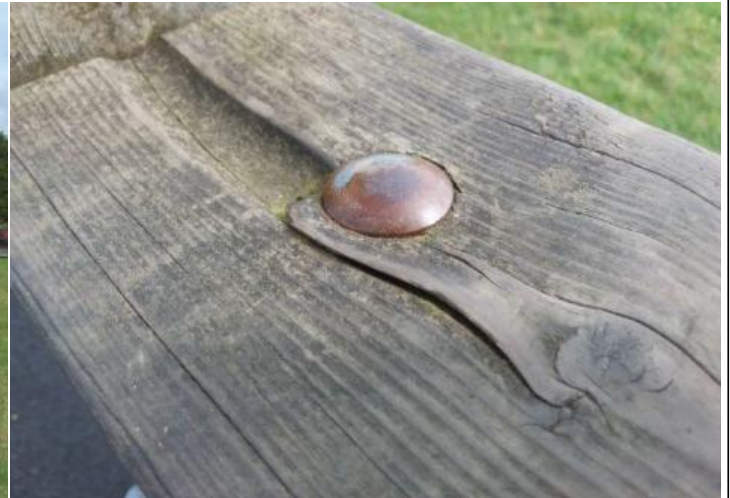
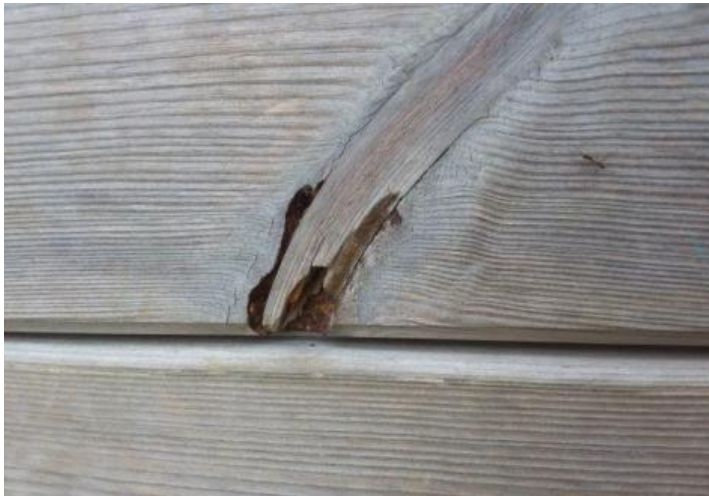
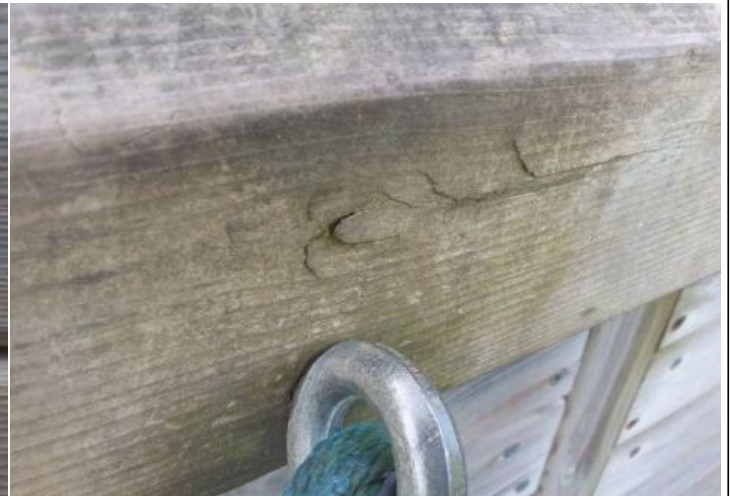
Item: Activity Equipment - Multi Play (Junior)
Manufacturer: Not Identified

Finding: Parts of the timber are rough or splintered

Action: Remove all rough or sharp edges

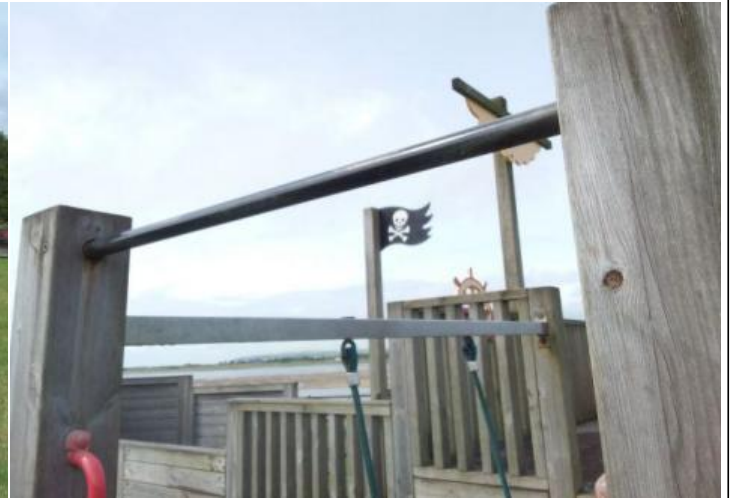
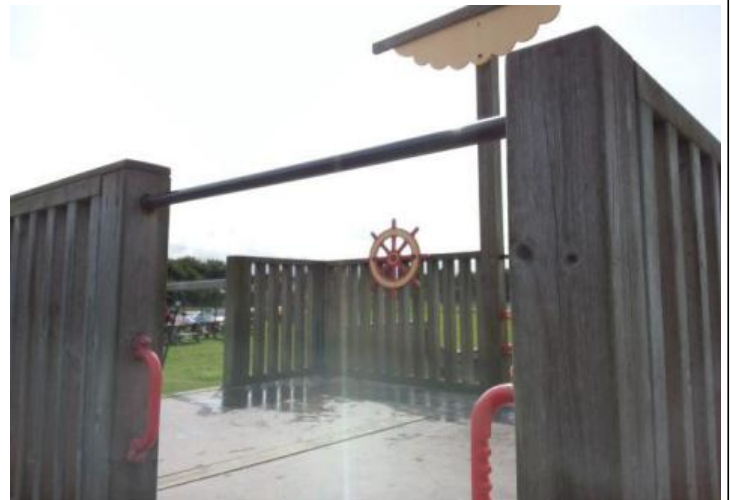
Item: Activity Equipment - Multi Play (Junior)
Manufacturer: Not Identified

Finding: The rails partially rotate

Action: Secure to prevent rotation

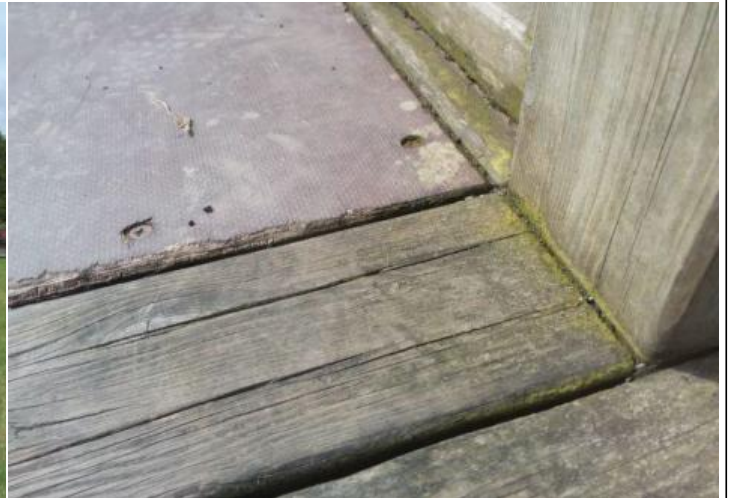
Item: Activity Equipment - Multi Play (Junior)
Manufacturer: Not Identified

Finding: There is algae or moss on the surface of the equipment

Action: Clean and treat appropriately
